## General Information

| Make | Toyota | Model | Wigo |
| YOM | 2021 | Mileage | 39,461 |
| Registration No. | NDZ5404 | Chassis No. | MHKA4DF5FMJ055587 |

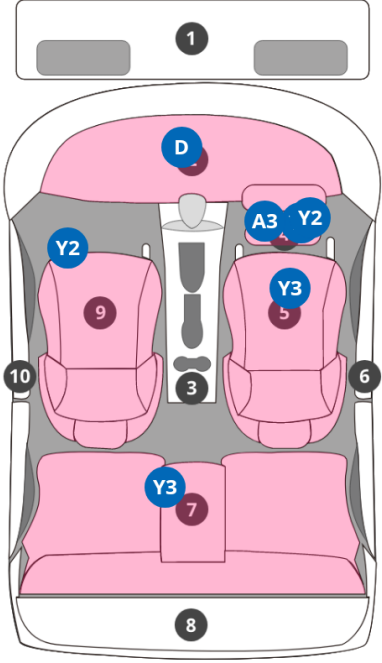
| <b>Interior Evaluation :</b> <span style="color: red; font-weight: bold;">C</span> | <b>Exterior Evaluation :</b> <span style="color: red; font-weight: bold;">E</span> |
| <b>Remarks</b><br>Mat Other - Grime - Large / Carpet - Worn, Scratch, Cut, Crack - Medium / Rear Seat - Grime - Medium / (L) Front Seat - Grime - Small / (R) Front Seat - Grime - Medium / (R) Front Floor Mat - Grime - Small / Dashboard - Traces of Adhesive Tape - Yes | <b>Remarks</b><br>Rear Bumper, Lamps, Panels - Scratch - Medium / (R) Front Door, Molding - Scratch & Dent - Medium / Front Bumper, Grille, Lamps - Scratch & Dent - Large / (L) Front Door, Molding - Scratch - Large / (L) Rear Door, Molding - Scratch & Dent - Large / (L) Step, In-panel, Side Spoiler - Scratch - Small / Trunk Hood, Rear Gate - Scratch - Minimal / (R) Rear Fender, Molding - Scratch - Small / (R) Center Panel - Scratch - Small / (R) Rear Door, Molding - Scratch - Small / Roof - Scratch - Small / (R) Mirror - Crack - Damaged |

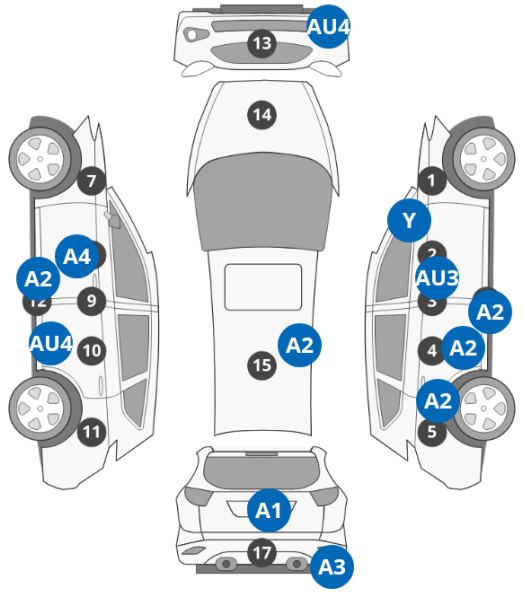
| with warranty booklet/ incomplete tools/ no spare tire/ no jack/ right side mirror cover missing/ left fog light not working/ with LTO plate/ |
