General Information

Make	Suzuki	Model	Ertiga
YOM	2025	Odo Meter Reading	5,484
Registration No.	KNV1827	Chassis No.	MHYNC32S4SJ101371
CC	1.5	Transmission	A/T
Fuel Type	Hybrid	Type of Body	Wagon
Colour	White

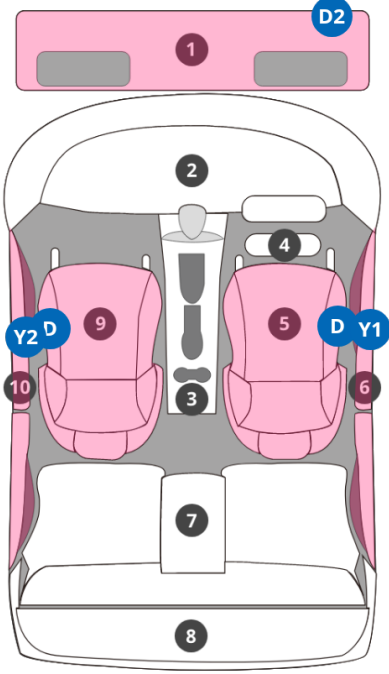
Interior Evaluation : B	Exterior Evaluation : C

<p>a : Cut, Fray d : Loose, Deformed k : Animal Hair s : Smell t : Cigarette Burns x : Defective y : Stain</p>

<p>A : Scratch AU : Scratch & Dent B : Modified C : Corrosion G : Stone chip P : Faded S : Rust SC : Rust & Corrosion U : Dent X : Defective Y : Crack, Gap</p>
<p>Remarks (R) Front Seat - Worn - Yes / (L) Front Seat - Worn - Yes / (L) Front Trim - Grime - Small / (R) Front Trim - Grime - Minimal / Ceiling - Crinkle - Small</p>	<p>Remarks (L) Front Door - Repair Traces - Yes / (R) Mirror - Scratch - Minimal / (R) Front Fender, Molding - Scratch & Dent - Medium / (R) Step, In-panel, Side Spoiler - Scratch & Dent - Minimal / (R) Front Door, Molding - Dent - Minimal / (R) Rear Door, Molding - Scratch - Medium / (R) Rear Fender, Molding - Scratch & Dent - Small / Rear Bumper, Lamps, Panels - Scratch - Small / Trunk Hood, Rear Gate - Scratch - Small / (L) Rear Fender, Molding - Scratch - Minimal / (L) Rear Door, Molding - Scratch - Minimal / (L) Mirror - Scratch - Small / (L) Front Door, Molding - Scratch - Minimal / (L) Front Fender, Molding - Scratch - Minimal / Front Bumper, Grille, Lamps - Scratch - Small / Bonnet, Headlight - Scratch - Minimal / Roof - Scratch - Small</p>

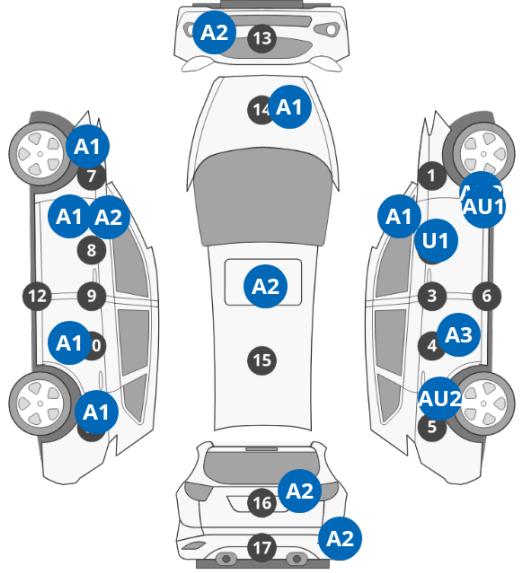
<p>Inspector Notes</p>
<p>with warranty booklet, jack and tools, with spare tire, with LTO plate, scratches on tail light and headlight</p>
