General Information

Make	Mitsubishi	Model	Xpander
YOM	2022	Odo Meter Reading	129,802
Registration No.	NFJ4466	Chassis No.	MK2LRNC1WNN004027
CC	1.5	Transmission	A/T
Fuel Type	Gas	Type of Body	Wagon
Colour	Gray

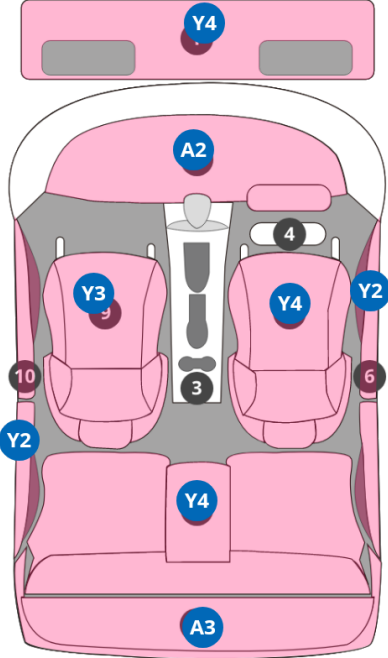
Interior Evaluation : D	Exterior Evaluation : E

<p>a : Cut, Fray d : Loose, Deformed k : Animal Hair s : Smell t : Cigarette Burns x : Defective y : Stain</p>

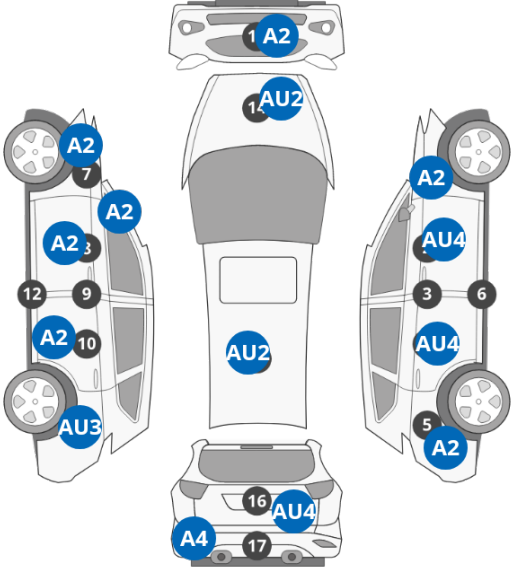
<p>A : Scratch AU : Scratch & Dent B : Modified C : Corrosion G : Stone chip P : Faded S : Rust SC : Rust & Corrosion U : Dent X : Defective Y : Crack, Gap</p>
<p>Remarks (R) Front Seat - Grime - Large / (R) Front Trim - Grime - Small / Rear Seat - Grime - Large / Trunk Room - Worn, Scratch, Cut, Crack - Medium / (L) Rear Trim - Grime - Small / (L) Front Seat - Grime - Medium / Ceiling - Grime - Large / Dashboard - Worn, Scratch, Cut, Crack - Small</p>	<p>Remarks (R) Rear Door, Molding - Scratch & Dent - Large / (R) Rear Fender, Molding - Scratch - Small / Trunk Hood, Rear Gate - Scratch & Dent - Large / Rear Bumper, Lamps, Panels - Scratch - Large / (L) Rear Fender, Molding - Scratch & Dent - Medium / (L) Rear Door, Molding - Scratch - Small / (L) Front Door, Molding - Scratch - Small / (L) Mirror - Scratch - Small / (L) Front Fender, Molding - Scratch - Small / (R) Front Fender, Molding - Scratch - Small / (R) Front Door, Molding - Scratch & Dent - Large / Front Bumper, Grille, Lamps - Scratch - Small / Roof - Scratch & Dent - Small / Bonnet, Headlight - Scratch & Dent - Small</p>
