General Information

Make	Mitsubishi	Model	Mirage
YOM	2025	Odo Meter Reading	2,338
Registration No.	GBB1868	Chassis No.	PAEA13MJSSA000523
CC	1.2	Transmission	M/T
Fuel Type	Gas	Type of Body	Sedan
Colour	Silver

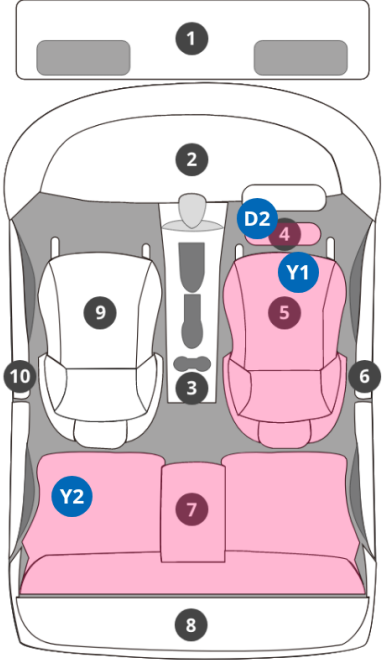
Interior Evaluation : A	Exterior Evaluation : C

<p>a : Cut, Fray d : Loose, Deformed k : Animal Hair s : Smell t : Cigarette Burns x : Defective y : Stain</p>

<p>A : Scratch AU : Scratch & Dent B : Modified C : Corrosion G : Stone chip P : Faded S : Rust SC : Rust & Corrosion U : Dent X : Defective Y : Crack, Gap</p>
<p>Remarks (L) Front Floor Mat - Worked - Small / (R) Front Seat - Grime - Minimal / Rear Seat - Grime - Small</p>	<p>Remarks (R) Front Door, Molding - Scratch - Medium / (R) Front Fender, Molding - Scratch - Minimal / (R) Rear Door, Molding - Scratch - Minimal / (R) Rear Fender, Molding - Scratch - Minimal / Rear Bumper, Lamps, Panels - Scratch - Minimal / Trunk Hood, Rear Gate - Scratch - Small / (L) Rear Fender, Molding - Scratch - Small / (L) Rear Door, Molding - Scratch - Small / (L) Front Door, Molding - Scratch & Dent - Small / (L) Front Fender, Molding - Scratch - Small / Front Bumper, Grille, Lamps - Scratch - Minimal / Bonnet, Headlight - Scratch - Small / Roof - Scratch - Minimal</p>

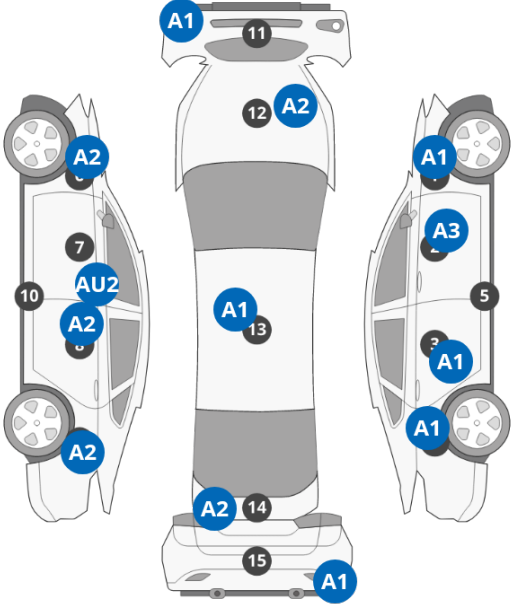
<p>Inspector Notes</p>
<p>with warranty booklet, no jack and tools, with spare tire, with LTO plate, scratches on tail light</p>
