General Information

Make	Mitsubishi	Model	Mirage
YOM	2025	Odo Meter Reading	7,777
Registration No.	NKM3998	Chassis No.	PAEA13RJSRA002373
CC	1.2	Transmission	CVT
Fuel Type	Gas	Type of Body	Sedan
Colour	Silver

Body / Panel Condition

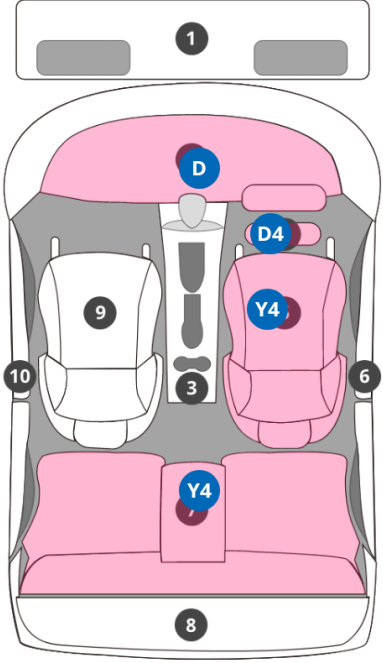
Interior Evaluation : C	Exterior Evaluation : E

<p>a : Cut, Fray d : Loose, Deformed k : Animal Hair s : Smell t : Cigarette Burns x : Defective y : Stain</p>

<p>A : Scratch AU : Scratch & Dent B : Modified C : Corrosion G : Stone chip P : Faded S : Rust SC : Rust & Corrosion U : Dent X : Defective Y : Crack, Gap</p>
<p>Remarks Rear Seat - Grime - Large / (R) Front Seat - Grime - Large / (L) Front Floor Mat - Worked - Large / Dashboard - Traces of Adhesive Tape - Yes</p>	<p>Remarks Bonnet - Repair Traces - Yes / Front Bumper, Grille, Lamps - Scratch & Dent - Medium / Bonnet, Headlight - Scratch & Dent - Small / (R) Front Fender, Molding - Scratch & Dent - Small / (R) Front Door, Molding - Scratch & Dent - Large / (R) Step, In-panel, Side Spoiler - Scratch & Dent - Small / (R) Rear Door, Molding - Dent - Small / (R) Rear Fender, Molding - Scratch - Large / Rear Bumper, Lamps, Panels - Scratch & Dent - Medium / (L) Rear Door, Molding - Scratch - Large / (L) Front Door, Molding - Dent - Small / Trunk Hood, Rear Gate - Scratch - Small / (L) Mirror - Scratch - Small</p>
