## General Information

| Make | Toyota | Model | Vios |
| YOM | 2021 | Mileage | 37,429 |

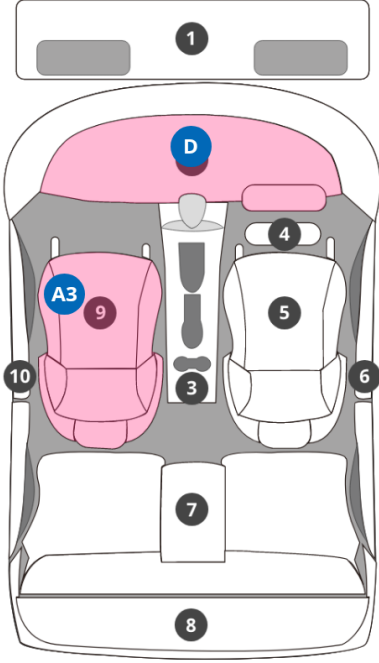
| Interior Evaluation : <b>B</b> | Exterior Evaluation : <b>B</b> |
|---|---|
| <p><b>Remarks</b><br/>(L) Front Seat - Cut, Crack - Medium / Dashboard - Traces of Adhesive Tape - Yes</p> | <p><b>Remarks</b><br/>(R) Front Fender - Repair Traces - Yes / (L) Rear Fender - Repair Traces - Yes / Bonnet, Headlight - Dent - Small / (L) Rear Door, Molding - Scratch &amp; Dent - Minimal / (L) Rear Fender, Molding - Scratch - Medium / (R) Rear Fender, Molding - Dent - Small / Front Bumper, Grille, Lamps - Scratch - Small / (L) Front Door, Molding - Scratch - Small</p> |
