General Information

Make	Toyota	Model	Hiace
YOM	2025	Odo Meter Reading	40,086
Registration No.	CCG3258	Chassis No.	JTFJT02P2R5039041
CC	3.0	Transmission	M/T
Fuel Type	Diesel	Type of Body	Van
Colour	Silver

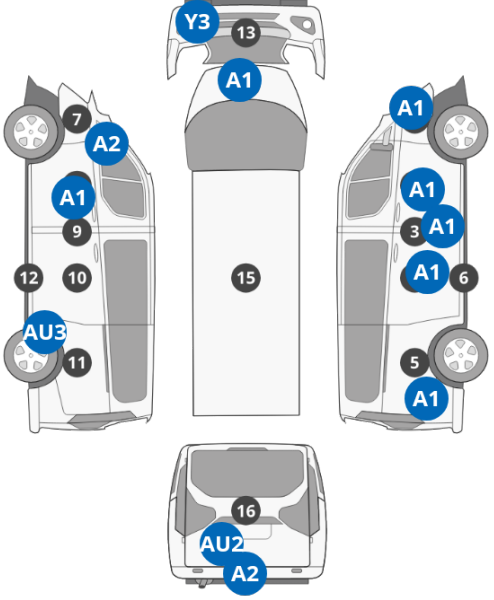
Interior Evaluation :	A	Exterior Evaluation :	C

<p>a : Cut, Fray d : Loose, Deformed k : Animal Hair s : Smell t : Cigarette Burns x : Defective y : Stain</p>		<p>A : Scratch AU : Scratch & Dent B : Modified C : Corrosion G : Stone chip P : Faded S : Rust SC : Rust & Corrosion U : Dent X : Defective Y : Crack, Gap</p>	
<p>Remarks Defects not found</p>		<p>Remarks (R) Front Fender, Molding - Scratch - Minimal / (R) Front Door, Molding - Scratch - Minimal / (R) Center Panel - Scratch - Minimal / (R) Rear Door, Molding - Scratch - Minimal / (R) Rear Fender, Molding - Scratch - Minimal / Trunk Hood, Rear Gate - Scratch & Dent - Small / Rear Bumper, Lamps, Panels - Scratch - Small / (L) Rear Fender, Molding - Scratch & Dent - Medium / (L) Mirror - Scratch - Small / (L) Front Door, Molding - Scratch - Minimal / Front Bumper, Grille, Lamps - Crack, Gap - Medium / Bonnet, Headlight - Scratch - Minimal</p>

With Lto plate, with warranty booklet, 1key, no spare tire, no jack and tools, scratches on headlights and taillights, front seat unjuster handle missing, fog light switch issue,
