General Information

Make	Kia	Model	Sonet
YOM	2024	Odo Meter Reading	11,736
Registration No.	KBB8935	Chassis No.	LJD3BA1DER0020721
CC	1.5	Transmission	A/T
Fuel Type	Gas	Type of Body	SUV
Colour	Blue

Body / Panel Condition

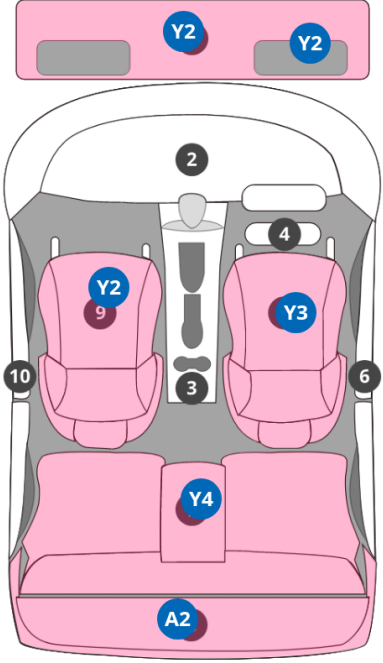
Interior Evaluation : C	Exterior Evaluation : C

<p>a : Cut, Fray d : Loose, Deformed k : Animal Hair s : Smell t : Cigarette Burns x : Defective y : Stain</p>

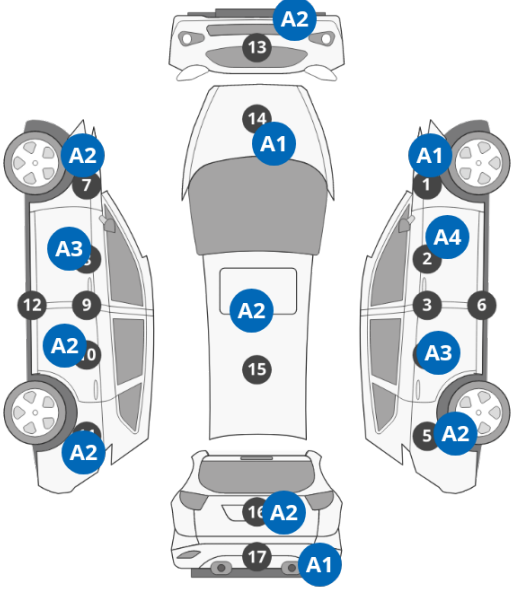
<p>A : Scratch AU : Scratch & Dent B : Modified C : Corrosion G : Stone chip P : Faded S : Rust SC : Rust & Corrosion U : Dent X : Defective Y : Crack, Gap</p>
<p>Remarks (R) Front Seat - Grime - Medium / Rear Seat - Grime - Large / Trunk Room - Worn, Scratch, Cut, Crack - Small / (L) Front Seat - Grime - Small / Sunvisor, Sunglass Holder - Grime - Small / Ceiling - Grime - Small</p>	<p>Remarks (R) Front Door - Repair Traces - Yes / Trunk Hood, Rear Gate - Repair Traces - Yes / (L) Rear Door, Molding - Scratch - Small / (L) Rear Fender, Molding - Scratch - Small / (L) Front Door, Molding - Scratch - Medium / (L) Front Fender, Molding - Scratch - Small / Front Bumper, Grille, Lamps - Scratch - Small / (R) Front Fender, Molding - Scratch - Minimal / Bonnet, Headlight - Scratch - Minimal / (R) Front Door, Molding - Scratch - Large / (R) Rear Door, Molding - Scratch - Medium / (R) Rear Fender, Molding - Scratch - Small / Trunk Hood, Rear Gate - Scratch - Small / Rear Bumper, Lamps, Panels - Scratch - Minimal / Roof - Scratch - Small</p>
