General Information

Make	Geely	Model	Emgrand
YOM	2023	Odo Meter Reading	17,644
Registration No.	ZAF2118	Chassis No.	LB3F31021PG008768
CC	1.5	Transmission	CVT
Fuel Type	Gas	Type of Body	Sedan
Colour	Red

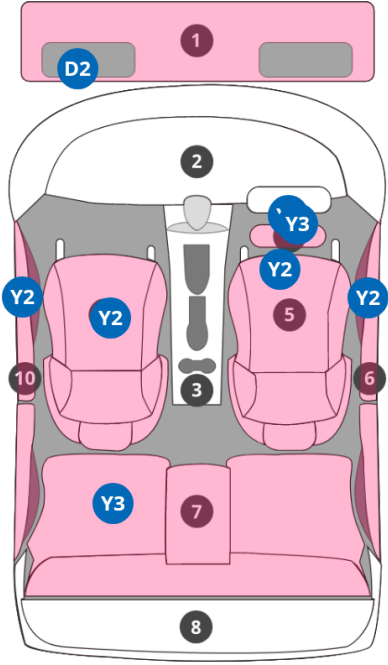
Interior Evaluation : C	Exterior Evaluation : D

<p>a : Cut, Fray d : Loose, Deformed k : Animal Hair s : Smell t : Cigarette Burns x : Defective y : Stain</p>

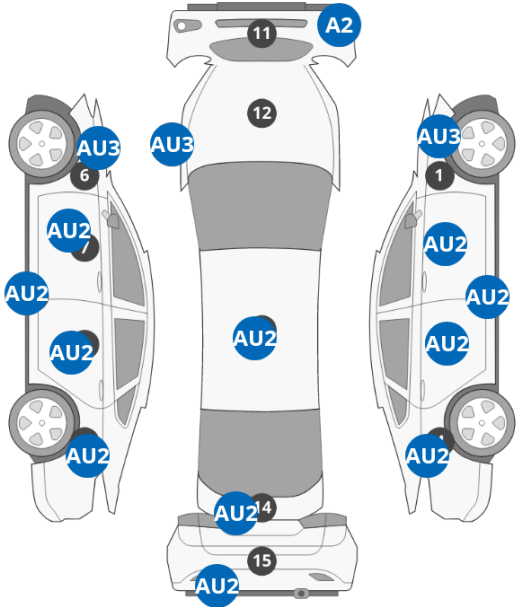
<p>A : Scratch AU : Scratch & Dent B : Modified C : Corrosion G : Stone chip P : Faded S : Rust SC : Rust & Corrosion U : Dent X : Defective Y : Crack, Gap</p>
<p>Remarks (L) Front Seat - Grime - Small / (R) Front Seat - Grime - Small / Rear Seat - Grime - Medium / (L) Front Floor Mat - Grime - Medium / (R) Front Floor Mat - Grime - Medium / (L) Front Trim - Grime - Small / (R) Front Trim - Grime - Small / Sunvisor, Sunglass Holder - Worked - Small</p>	<p>Remarks Roof - Scratch & Dent - Small / (L) Rear Door, Molding - Scratch & Dent - Small / (L) Front Fender, Molding - Scratch & Dent - Medium / Bonnet, Headlight - Scratch & Dent - Medium / Front Bumper, Grille, Lamps - Scratch - Small / (R) Front Fender, Molding - Scratch & Dent - Medium / (R) Front Door, Molding - Scratch & Dent - Small / (R) Step, In-panel, Side Spoiler - Scratch & Dent - Small / (R) Rear Door, Molding - Scratch & Dent - Small / Trunk Hood, Rear Gate - Scratch & Dent - Small / Rear Bumper, Lamps, Panels - Scratch & Dent - Small / (L) Step, In-panel, Side Spoiler - Scratch & Dent - Small / (L) Front Door, Molding - Scratch & Dent - Small / (L) Rear Fender, Molding - Scratch & Dent - Small / (R) Rear Fender, Molding - Scratch & Dent - Small</p>
