## General Information

<b>Make</b>	Hyundai	<b>Model</b>	Tucson
<b>YOM</b>	2012	<b>Odo Meter Reading</b>	154,762
<b>Registration No.</b>	TVO172	<b>Chassis No.</b>	KMHJU81BBBU460773
<b>CC</b>	2.0	<b>Transmission</b>	A/T
<b>Fuel Type</b>	Gas	<b>Type of Body</b>	SUV
<b>Colour</b>	Gray

## Body / Panel Condition

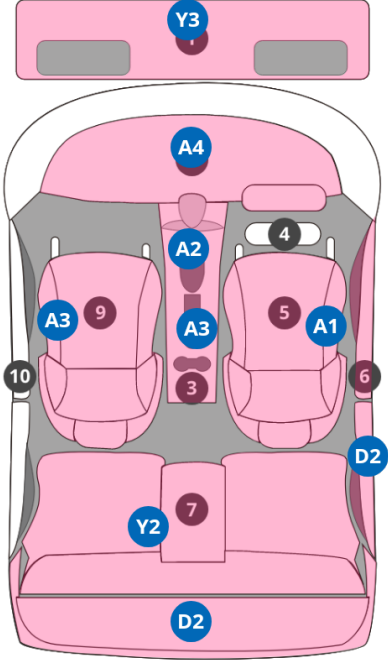
<b>Interior Evaluation :</b> <span style="float: right; color: red; font-weight: bold;">C</span>	<b>Exterior Evaluation :</b> <span style="float: right; color: red; font-weight: bold;">E</span>

<p><b>a</b> : Cut, Fray <b>d</b> : Loose, Deformed <b>k</b> : Animal Hair <b>s</b> : Smell <b>t</b> : Cigarette Burns <b>x</b> : Defective <b>y</b> : Stain</p>

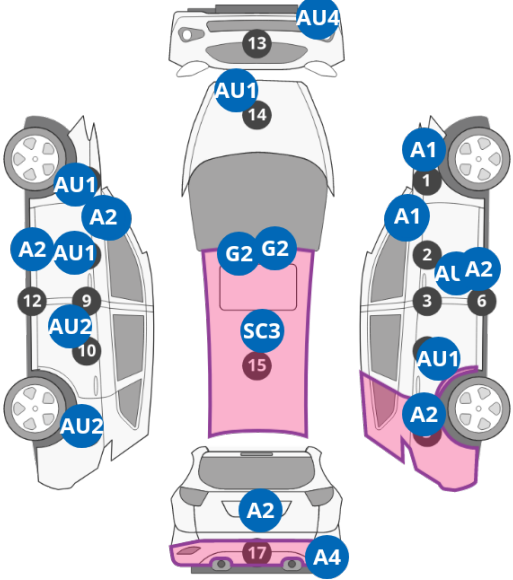
<p><b>A</b> : Scratch <b>AU</b> : Scratch &amp; Dent <b>B</b> : Modified <b>C</b> : Corrosion <b>G</b> : Stone chip <b>P</b> : Faded <b>S</b> : Rust <b>SC</b> : Rust &amp; Corrosion <b>U</b> : Dent <b>X</b> : Defective <b>Y</b> : Crack, Gap</p>
<p><b>Remarks</b> Ceiling - Grime - Medium / Steering Wheel - Worn, Peel, Crack - Large / Knobs - Worn, Peel, Crack - Small / Console, Switches, Vents - Worn, Scratch, Cut, Crack - Medium / (L) Front Seat - Cut, Crack - Medium / Rear Seat - Grime - Small / (R) Rear Trim - Loose, Deformed - Small / (R) Front Seat - Cut, Crack - Minimal / Trunk Room - Loose, Deformed - Small</p>	<p><b>Remarks</b> (R) Rear Fender - Repair Traces - Yes / (R) Front Fender, Molding - Scratch - Minimal / (R) Mirror - Faded(Color, Gloss) - Yes / (R) Mirror - Scratch - Minimal / (R) Front Door, Molding - Scratch &amp; Dent - Small / (R) Step, In-panel, Side Spoiler - Scratch - Small / (R) Rear Door, Molding - Scratch &amp; Dent - Minimal / (R) Rear Fender, Molding - Repair mark - Yes / (R) Rear Fender, Molding - Scratch - Small / Rear Bumper, Lamps, Panels - Repair mark - Yes / Rear Bumper, Lamps, Panels - Scratch - Large / Trunk Hood, Rear Gate - Scratch - Small / Roof Spoiler, Molding - Partially Missing - Yes / (L) Rear Fender, Molding - Scratch &amp; Dent - Small / Roof - Rust, Corrosion - Medium / (L) Rear Door, Molding - Scratch &amp; Dent - Small / (L) Mirror - Faded(Color, Gloss) - Yes / (L) Mirror - Scratch - Small / (L) Front Door, Molding - Scratch &amp; Dent - Minimal / (L) Step, In-panel, Side Spoiler - Scratch - Small / (L) Front Fender, Molding - Scratch &amp; Dent - Minimal / Front Bumper, Grille, Lamps - Scratch &amp; Dent - Large / Bonnet, Headlight - Scratch &amp; Dent - Minimal / Front Windshield - Scratch, Stone chip - Small / Rear Windshield - Scratch, Stone chip - Small</p>
