General Information

Make	Toyota	Model	Innova
YOM	2025	Odo Meter Reading	38,324
Registration No.	GBF9381	Chassis No.	PA2JA8EM8R0150219
CC	2.8	Transmission	A/T
Fuel Type	Diesel	Type of Body	MPV
Colour	Red Mica Metallic

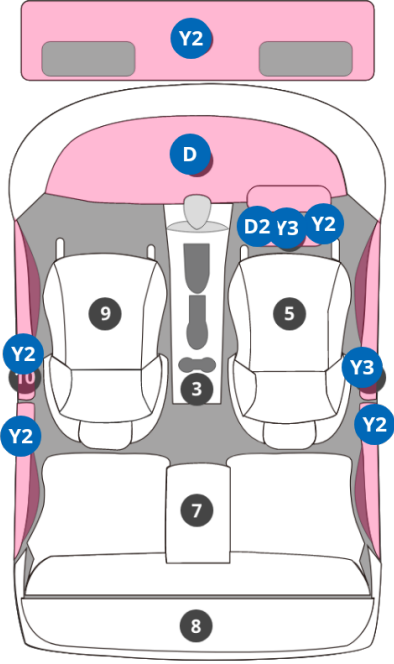
Interior Evaluation : C	Exterior Evaluation : E

<p>a : Cut, Fray d : Loose, Deformed k : Animal Hair s : Smell t : Cigarette Burns x : Defective y : Stain</p>

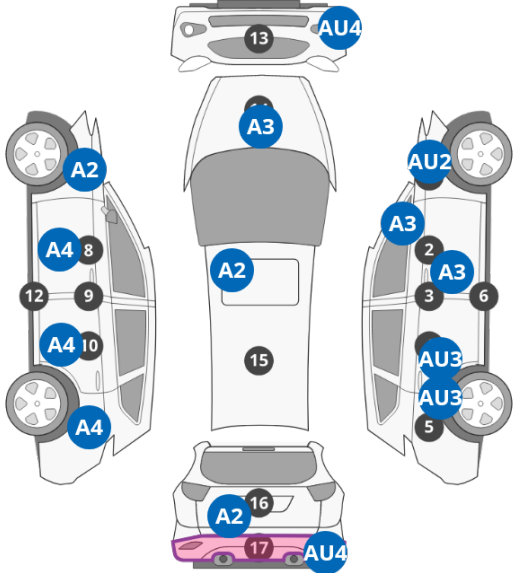
<p>A : Scratch AU : Scratch & Dent B : Modified C : Corrosion G : Stone chip P : Faded S : Rust SC : Rust & Corrosion U : Dent X : Defective Y : Crack, Gap</p>
<p>Remarks (R) Front Trim - Grime - Medium / (R) Front Floor Mat - Grime - Small / Dashboard - Traces of Adhesive Tape - Yes / Ceiling - Grime - Small / (R) Rear Trim - Grime - Small / Mat Other - Grime - Medium / (L) Rear Trim - Grime - Small / (L) Front Trim - Grime - Small / (L) Front Floor Mat - Worked - Small</p>	<p>Remarks (L) Front Fender, Molding - Scratch - Small / (L) Front Door, Molding - Scratch - Large / (L) Rear Door, Molding - Scratch - Large / (L) Rear Fender, Molding - Scratch - Large / Rear Bumper, Lamps, Panels - Repair mark - Difference in Color / Rear Bumper, Lamps, Panels - Scratch & Dent - Large / (R) Rear Fender, Molding - Scratch & Dent - Medium / (R) Rear Door, Molding - Scratch & Dent - Medium / (R) Front Door, Molding - Scratch - Medium / (R) Mirror - Scratch - Medium / Bonnet, Headlight - Scratch - Medium / Front Bumper, Grille, Lamps - Scratch & Dent - Large / Roof - Scratch - Small / Trunk Hood, Rear Gate - Scratch - Small / (R) Front Fender, Molding - Scratch & Dent - Small</p>

<p>Inspector Notes</p>
<p>Possible floosing. Crack left taillight. Scratches at signal light right side.No warranty booklet. With spare tire, jack, tools. 2 keys. With LTO plate</p>
