General Information

Make	Toyota	Model	Vios
YOM	2025	Odo Meter Reading	34,787
Registration No.	HAG8734	Chassis No.	PA1B18F3XR4269123
CC	1.3	Transmission	CVT
Fuel Type	Gas	Type of Body	Sedan
Colour	Silver

Body / Panel Condition

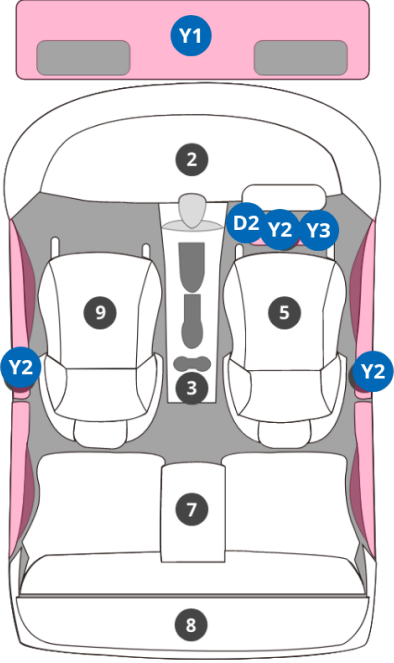
Interior Evaluation : B	Exterior Evaluation : D

<p>a : Cut, Fray d : Loose, Deformed k : Animal Hair s : Smell t : Cigarette Burns x : Defective y : Stain</p>

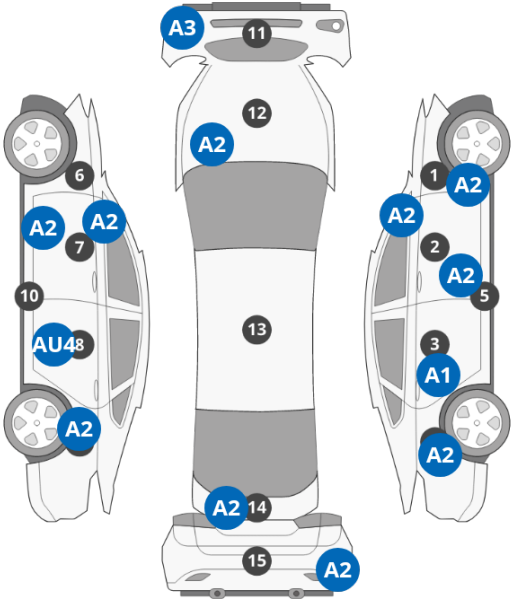
<p>A : Scratch AU : Scratch & Dent B : Modified C : Corrosion G : Stone chip P : Faded S : Rust SC : Rust & Corrosion U : Dent X : Defective Y : Crack, Gap</p>
<p>Remarks (R) Front Trim - Grime - Small / (R) Front Floor Mat - Grime - Medium / Ceiling - Grime - Minimal / Mat Other - Grime - Small / (L) Front Trim - Grime - Small / (L) Front Floor Mat - Worked - Small</p>	<p>Remarks (L) Mirror - Scratch - Small / (L) Front Door, Molding - Scratch - Small / (L) Rear Door, Molding - Scratch & Dent - Large / (L) Rear Fender, Molding - Scratch - Small / Trunk Hood, Rear Gate - Scratch - Small / Rear Bumper, Lamps, Panels - Scratch - Small / (R) Rear Fender, Molding - Scratch - Small / (R) Rear Door, Molding - Scratch - Minimal / (R) Mirror - Scratch - Small / (R) Front Door, Molding - Scratch - Small / (R) Front Fender, Molding - Scratch - Small / Bonnet, Headlight - Scratch - Small / Front Bumper, Grille, Lamps - Scratch - Medium</p>
