## General Information

| Make | Toyota | Model | Vios |
| YOM | 2021 | Mileage | 37,325 |

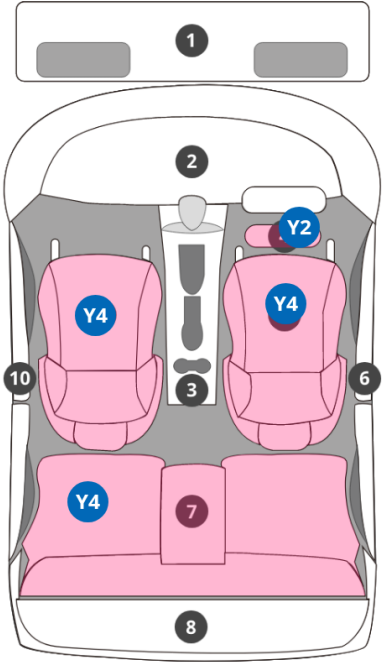
| Interior Evaluation : <span style="color: red;">C</span> | Exterior Evaluation : <span style="color: red;">C</span> |
| <b>Remarks</b><br>(L) Front Floor Mat - Grime - Small / (L) Front Seat - Grime - Large / Rear Seat - Grime - Large / (R) Front Seat - Grime - Large | <b>Remarks</b><br>Trunk Hood, Rear Gate - Dent - Medium / Front Bumper, Grille, Lamps - Scratch - Large / (R) Rear Fender, Molding - Scratch & Dent - Medium / Roof - Dent - Small / (R) Rear Door, Molding - Dent - Minimal / (R) Front Door, Molding - Dent - Small / (L) Rear Door, Molding - Scratch - Small / Rear Bumper, Lamps, Panels - Scratch - Small |

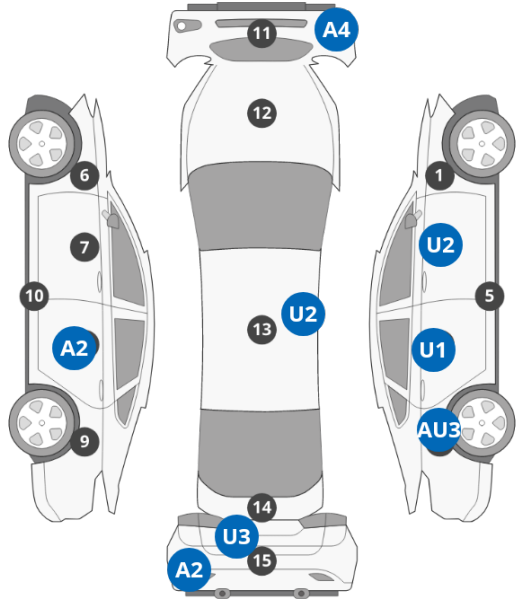
| Inspector Notes |
|---|
| with LTO plate number/with spare tire/ jack/No reverse camera/ No warranty booklet/No tools/ rear left tail light crack |
