General Information

Make	Toyota	Model	Lite Ace
YOM	2023	Odo Meter Reading	60,562
Registration No.	FAP1384	Chassis No.	MHKU3FE10PK0041
CC	1.5	Transmission	M/T
Fuel Type	Gas	Type of Body	Utility Passenger
Colour	White

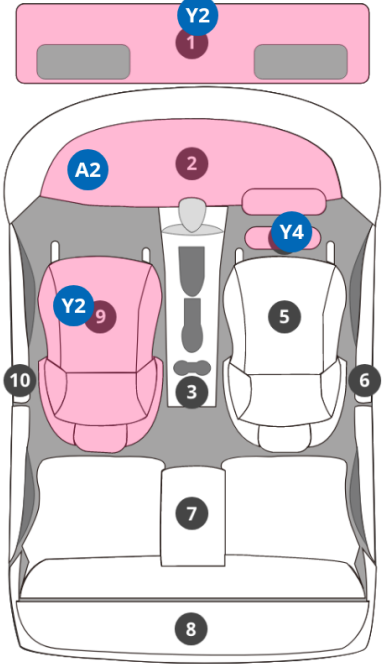
Interior Evaluation : C	Exterior Evaluation : B

<p>a : Cut, Fray d : Loose, Deformed k : Animal Hair s : Smell t : Cigarette Burns x : Defective y : Stain</p>

<p>A : Scratch AU : Scratch & Dent B : Modified C : Corrosion G : Stone chip P : Faded S : Rust SC : Rust & Corrosion U : Dent X : Defective Y : Crack, Gap</p>
<p>Remarks (R) Front Floor Mat - Grime - Large / Ceiling - Grime - Small / (L) Front Seat - Grime - Small / Dashboard - Worn, Scratch, Cut, Crack - Small</p>	<p>Remarks (R) Rear Door, Molding - Scratch - Small / Bonnet, Headlight - Scratch - Small / (R) Side Gate - Scratch - Medium / (L) Guard Frame - Scratch - Small / Cargo Bed Floor - Scratch & Dent - Medium</p>
Frame Evaluation : A	Functional Evaluation : B
<p>Remarks Defects not found</p>	<p>Remarks Battery - Weak - Yes</p>
