General Information

Make	Toyota	Model	Raize
YOM	2024	Odo Meter Reading	15,716
Registration No.	FAS1576	Chassis No.	MHKAA1BA0RJ127907
CC	1.0	Transmission	CVT
Fuel Type	Gas	Type of Body	Wagon
Colour	White

Body / Panel Condition

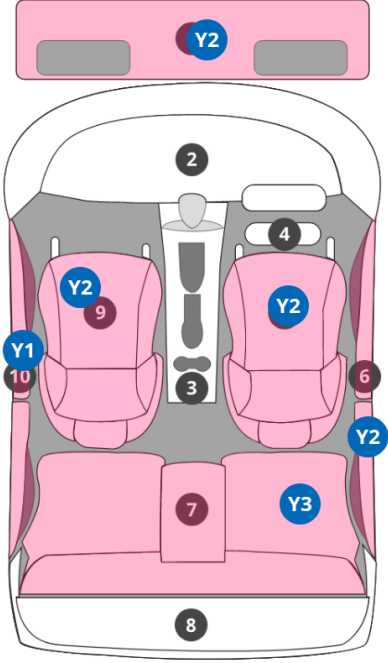
Interior Evaluation : B	Exterior Evaluation : B

<p>a : Cut, Fray d : Loose, Deformed k : Animal Hair s : Smell t : Cigarette Burns x : Defective y : Stain</p>

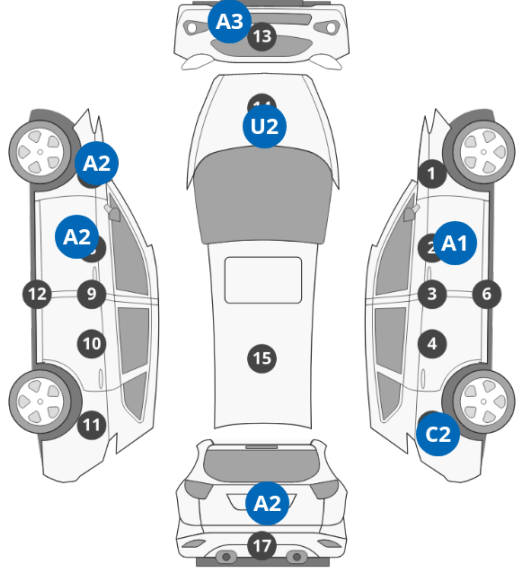
<p>A : Scratch AU : Scratch & Dent B : Modified C : Corrosion G : Stone chip P : Faded S : Rust SC : Rust & Corrosion U : Dent X : Defective Y : Crack, Gap</p>
<p>Remarks Rear Seat - Grime - Medium / (L) Front Seat - Grime - Small / (R) Front Seat - Grime - Small / Ceiling - Grime - Small / (L) Front Trim - Grime - Minimal / (R) Rear Trim - Grime - Small</p>	<p>Remarks Trunk Hood, Rear Gate - Repair Traces - Yes / Roof - Repair Traces - Yes / Front Bumper, Grille, Lamps - Scratch - Medium / Bonnet, Headlight - Dent - Small / (L) Front Door, Molding - Scratch - Small / (L) Front Fender, Molding - Scratch - Small / Trunk Hood, Rear Gate - Scratch - Small / (R) Front Door, Molding - Scratch - Minimal / (R) Rear Wheel, Cover - Scratch, Corrosion - Small</p>
