## General Information

<b>Make</b>	Toyota	<b>Model</b>	Vios
<b>YOM</b>	2025	<b>Odo Meter Reading</b>	42,182
<b>Registration No.</b>	EAJ6590	<b>Chassis No.</b>	PA1B18F39R4272109
<b>CC</b>	1.3	<b>Transmission</b>	CVT
<b>Fuel Type</b>	Gas	<b>Type of Body</b>	Sedan
<b>Colour</b>	Red

## Body / Panel Condition

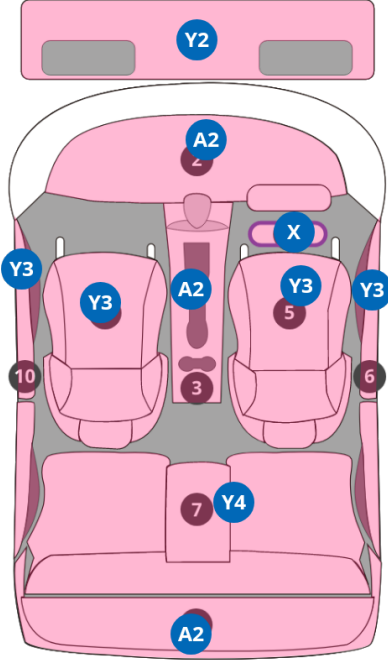
<b>Interior Evaluation :</b> <span style="float: right; color: red; font-weight: bold;">C</span>	<b>Exterior Evaluation :</b> <span style="float: right; color: red; font-weight: bold;">E</span>

<p><b>a</b> : Cut, Fray <b>d</b> : Loose, Deformed <b>k</b> : Animal Hair <b>s</b> : Smell <b>t</b> : Cigarette Burns <b>x</b> : Defective <b>y</b> : Stain</p>

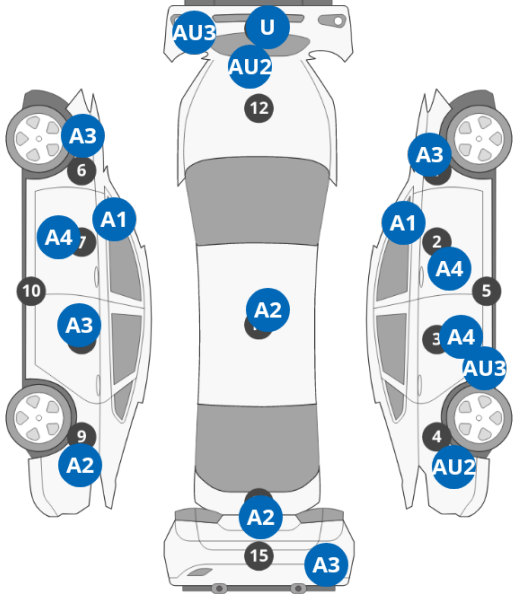
<p><b>A</b> : Scratch <b>AU</b> : Scratch &amp; Dent <b>B</b> : Modified <b>C</b> : Corrosion <b>G</b> : Stone chip <b>P</b> : Faded <b>S</b> : Rust <b>SC</b> : Rust &amp; Corrosion <b>U</b> : Dent <b>X</b> : Defective <b>Y</b> : Crack, Gap</p>
<p><b>Remarks</b> (R) Front Seat - Grime - Medium / (R) Front Trim - Grime - Medium / Rear Seat - Grime - Large / Mat Other - Missing - Yes / Trunk Room - Worn, Scratch, Cut, Crack - Small / (L) Front Trim - Grime - Medium / (L) Front Seat - Grime - Medium / Ceiling - Grime - Small / Dashboard - Worn, Scratch, Cut, Crack - Small / Console, Switchs, Vents - Worn, Scratch, Cut, Crack - Small</p>	<p><b>Remarks</b> Bonnet - Repair Traces - Yes / (L) Rear Fender - Repair Traces - Yes / Trunk Hood, Rear Gate - Scratch - Small / Rear Bumper, Lamps, Panels - Scratch - Medium / (R) Rear Fender, Molding - Scratch &amp; Dent - Small / (R) Rear Door, Molding - Scratch - Large / (R) Step, In-panel, Side Spoiler - Scratch &amp; Dent - Medium / (R) Front Door, Molding - Scratch - Large / (R) Mirror - Scratch - Minimal / (R) Front Fender, Molding - Scratch - Medium / Bonnet, Headlight - Scratch &amp; Dent - Small / Front Bumper, Grille, Lamps - Scratch &amp; Dent - Medium / (L) Front Fender, Molding - Scratch - Medium / (L) Mirror - Scratch - Minimal / (L) Front Door, Molding - Scratch - Large / (L) Rear Door, Molding - Scratch - Medium / (L) Rear Fender, Molding - Scratch - Small / Roof - Scratch - Small / Member (Bolted) - Dent - Yes</p>
