General Information

Date & Time: 16, Feb, 2026 14:46

Make	Toyota	Model	Raize
YOM	2025	Odo Meter Reading	20,275
Registration No.	EAJ8887	Chassis No.	MHKAB1BA1RJ113849
CC	1.2	Transmission	CVT
Fuel Type	Gas	Type of Body	Wagon
Colour	Gray

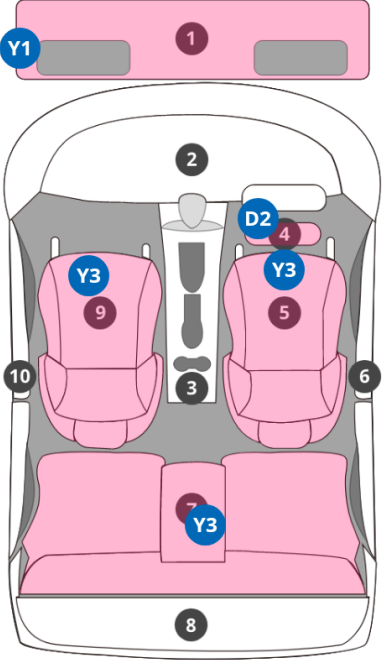
Interior Evaluation : B	Exterior Evaluation : E

<p>a : Cut, Fray d : Loose, Deformed k : Animal Hair s : Smell t : Cigarette Burns x : Defective y : Stain</p>

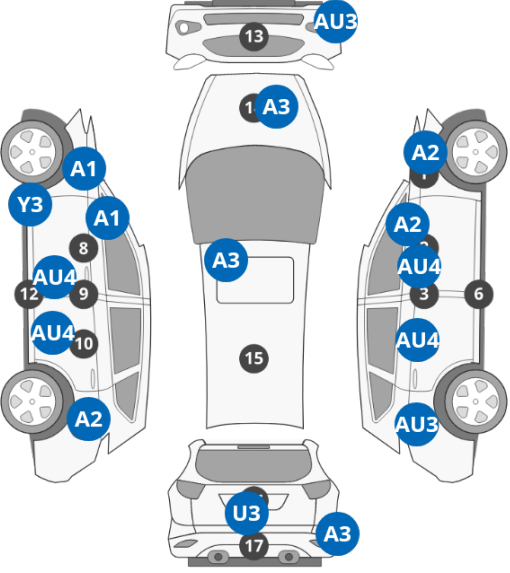
<p>A : Scratch AU : Scratch & Dent B : Modified C : Corrosion G : Stone chip P : Faded S : Rust SC : Rust & Corrosion U : Dent X : Defective Y : Crack, Gap</p>
<p>Remarks (L) Front Seat - Grime - Medium / (R) Front Seat - Grime - Medium / Rear Seat - Grime - Medium / (L) Front Floor Mat - Worked - Small / Ceiling - Grime - Minimal</p>	<p>Remarks (R) Front Door - Repair Traces - Yes / (L) Front Door - Repair Traces - Yes / (L) Rear Door - Repair Traces - Yes / (R) Front Door, Molding - Scratch & Dent - Large / (R) Rear Door, Molding - Scratch & Dent - Large / (R) Front Fender, Molding - Scratch - Small / (R) Mirror - Scratch - Small / (R) Rear Fender, Molding - Scratch & Dent - Medium / Rear Bumper, Lamps, Panels - Scratch - Medium / Trunk Hood, Rear Gate - Dent - Medium / (L) Rear Fender, Molding - Scratch - Small / (L) Rear Door, Molding - Scratch & Dent - Large / (L) Front Door, Molding - Scratch & Dent - Large / (L) Step, In-panel, Side Spoiler - Crack, Gap - Medium / (L) Mirror - Scratch - Minimal / (L) Front Fender, Molding - Scratch - Minimal / Front Bumper, Grille, Lamps - Scratch & Dent - Medium / Bonnet, Headlight - Scratch - Medium / Roof - Scratch - Medium</p>

<p>Inspector Notes</p>
<p>with warranty booklet, jack and tools, with spare tire, NO LTO plate, scratches on tail light</p>
