General Information

Make	Toyota	Model	Vios
YOM	2024	Odo Meter Reading	15,643
Registration No.	DCA5893	Chassis No.	PA1B18F3XR4253360
CC	1.3	Transmission	CVT
Fuel Type	Gas	Type of Body	Sedan
Colour	Red Mica Metallic

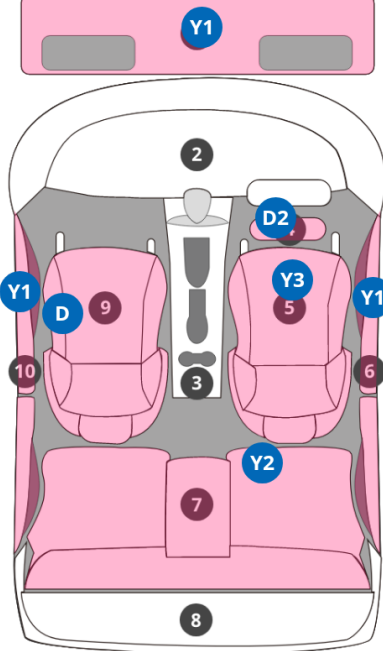
Interior Evaluation : B	Exterior Evaluation : D

<p>a : Cut, Fray d : Loose, Deformed k : Animal Hair s : Smell t : Cigarette Burns x : Defective y : Stain</p>

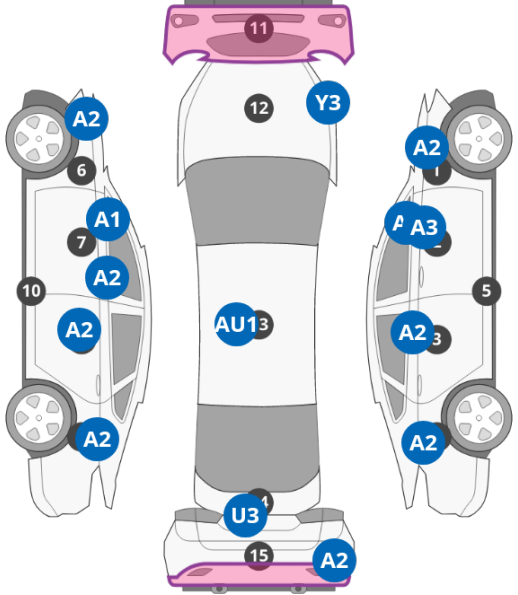
<p>A : Scratch AU : Scratch & Dent B : Modified C : Corrosion G : Stone chip P : Faded S : Rust SC : Rust & Corrosion U : Dent X : Defective Y : Crack, Gap</p>
<p>Remarks (R) Front Seat - Grime - Medium / (L) Front Seat - Worn - Yes / (L) Front Floor Mat - Worked - Small / (R) Front Trim - Grime - Minimal / (L) Front Trim - Grime - Minimal / Ceiling - Grime - Minimal / Rear Seat - Grime - Small</p>	<p>Remarks (R) Mirror - Scratch - Minimal / (R) Front Door, Molding - Scratch - Medium / (R) Front Fender, Molding - Scratch - Small / (R) Rear Door, Molding - Scratch - Small / (R) Rear Fender, Molding - Scratch - Small / Rear Bumper, Lamps, Panels - Scratch - Small / Rear Bumper, Lamps, Panels - Repair mark - Yes / Trunk Hood, Rear Gate - Dent - Medium / (L) Rear Fender, Molding - Scratch - Small / (L) Rear Door, Molding - Scratch - Small / (L) Front Door, Molding - Scratch - Small / (L) Mirror - Scratch - Minimal / (L) Front Fender, Molding - Scratch - Small / Front Bumper, Grille, Lamps - Repair mark - Yes / Bonnet, Headlight - Crack, Gap - Medium / Roof - Scratch & Dent - Minimal</p>

<p>Inspector Notes</p>
<p>no warranty booklet, with jack, no tools, with spare tire, no LTO plate, scratches on tail light, headlight issue</p>
