General Information

Make	Toyota	Model	Vios
YOM	2022	Odo Meter Reading	36,905
Registration No.	NFH9577	Chassis No.	PA1B18F36N4179476
CC	1.3	Transmission	CVT
Fuel Type	Gas	Type of Body	Sedan
Colour	Blue

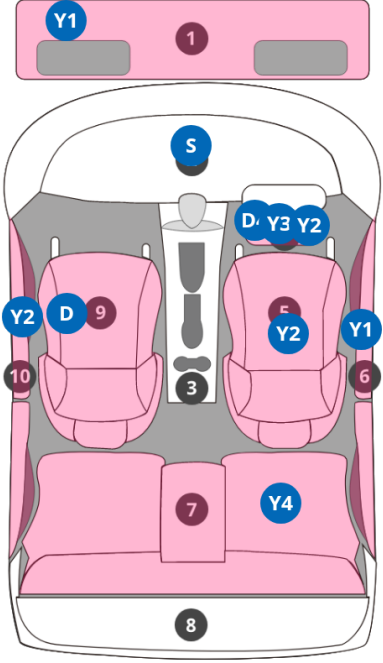
Interior Evaluation : C	Exterior Evaluation : E

<p>a : Cut, Fray d : Loose, Deformed k : Animal Hair s : Smell t : Cigarette Burns x : Defective y : Stain</p>

<p>A : Scratch AU : Scratch & Dent B : Modified C : Corrosion G : Stone chip P : Faded S : Rust SC : Rust & Corrosion U : Dent X : Defective Y : Crack, Gap</p>
<p>Remarks (L) Front Seat - Worn - Yes / Rear Seat - Grime - Large / (L) Front Floor Mat - Worked - Large / Mat Other - Grime - Medium / (R) Front Seat - Grime - Small / (R) Front Floor Mat - Grime - Small / (R) Front Trim - Grime - Minimal / Ceiling - Grime - Minimal / Overall Interior - Smell - Yes / (L) Front Trim - Grime - Small</p>	<p>Remarks Member (Bolted) - Dent - Yes / (R) Step, In-panel, Side Spoiler - Scratch & Dent - Medium / (R) Front Door, Molding - Scratch & Dent - Medium / (R) Mirror - Scratch - Minimal / (L) Mirror - Crack - Damaged / (R) Front Fender, Molding - Scratch - Minimal / (R) Rear Door, Molding - Scratch - Minimal / (R) Rear Fender, Molding - Scratch & Dent - Minimal / Rear Bumper, Lamps, Panels - Scratch - Medium / Trunk Hood, Rear Gate - Scratch & Dent - Small / (L) Rear Fender, Molding - Scratch - Small / (L) Rear Door, Molding - Scratch - Medium / (L) Step, In-panel, Side Spoiler - Scratch & Dent - Medium / (L) Front Door, Molding - Scratch & Dent - Small / (L) Mirror - Scratch - Minimal / (L) Front Fender, Molding - Scratch - Minimal / Front Bumper, Grille, Lamps - Scratch - Medium / Bonnet, Headlight - Scratch & Dent - Small / Roof - Scratch - Small</p>

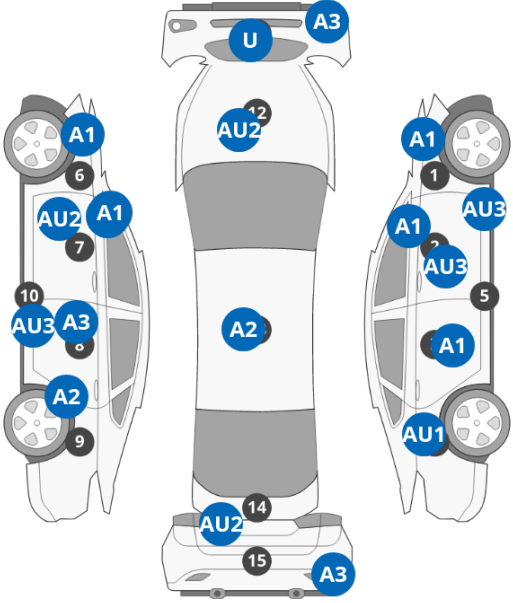
<p>Inspector Notes</p>
<p>no warranty booklet and tools, with jack, with spare tire, with LTO plate, scratches on tail light, possible flooding, left side mirror loose</p>
