General Information

Make	Toyota	Model	Vios
YOM	2024	Odo Meter Reading	85,865
Registration No.	NHR2200	Chassis No.	PA1B18F38P4226686
CC	1.3	Transmission	CVT
Fuel Type	Gas	Type of Body	Sedan
Colour	Black

Body / Panel Condition

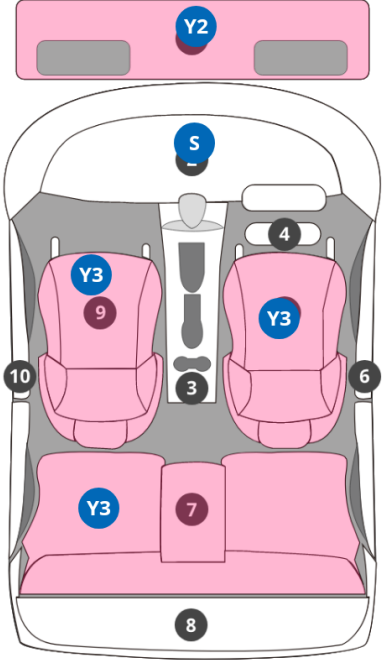
Interior Evaluation : C	Exterior Evaluation : C

<p>a : Cut, Fray d : Loose, Deformed k : Animal Hair s : Smell t : Cigarette Burns x : Defective y : Stain</p>

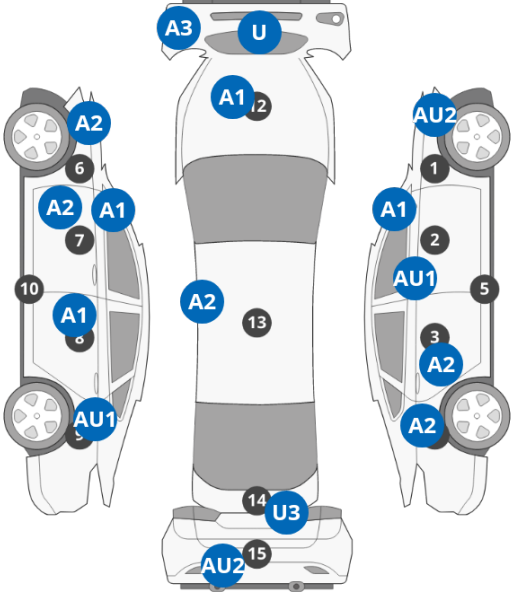
<p>A : Scratch AU : Scratch & Dent B : Modified C : Corrosion G : Stone chip P : Faded S : Rust SC : Rust & Corrosion U : Dent X : Defective Y : Crack, Gap</p>
<p>Remarks Rear Seat - Grime - Medium / (L) Front Seat - Grime - Medium / (R) Front Seat - Grime - Medium / Ceiling - Grime - Small / Overall Interior - Smell - Yes / Overall Interior - Worn as per age - Yes</p>	<p>Remarks (L) Rear Door - Repair Traces - Yes / (R) Front Fender, Molding - Scratch & Dent - Small / (R) Mirror - Scratch - Minimal / (R) Rear Door, Molding - Scratch - Small / (R) Front Door, Molding - Scratch & Dent - Minimal / (R) Rear Fender, Molding - Scratch - Small / Rear Bumper, Lamps, Panels - Scratch & Dent - Small / Trunk Hood, Rear Gate - Dent - Medium / (L) Rear Fender, Molding - Scratch & Dent - Minimal / (L) Front Door, Molding - Scratch - Small / (L) Rear Door, Molding - Scratch - Minimal / Member (Bolted) - Dent - Yes / (L) Mirror - Scratch - Minimal / (L) Front Fender, Molding - Scratch - Small / Front Bumper, Grille, Lamps - Scratch - Medium / Bonnet, Headlight - Scratch - Minimal / Roof - Scratch - Small</p>
