## General Information

<b>Make</b>	Toyota	<b>Model</b>	Vios
<b>YOM</b>	2025	<b>Odo Meter Reading</b>	37,999
<b>Registration No.</b>	NHU4659	<b>Chassis No.</b>	PA1B18F31R4271827
<b>CC</b>	1.3	<b>Transmission</b>	CVT
<b>Fuel Type</b>	Gas	<b>Type of Body</b>	Sedan
<b>Colour</b>	Blue

## Body / Panel Condition

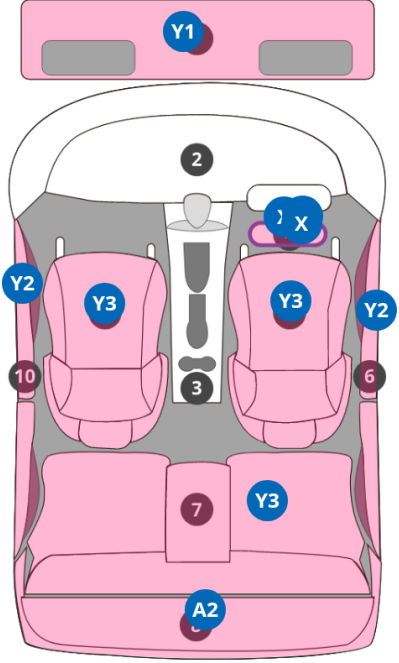
<b>Interior Evaluation :</b> <span style="float: right; color: red; font-weight: bold;">C</span>	<b>Exterior Evaluation :</b> <span style="float: right; color: red; font-weight: bold;">E</span>

<p><b>a</b> : Cut, Fray <b>d</b> : Loose, Deformed <b>k</b> : Animal Hair <b>s</b> : Smell <b>t</b> : Cigarette Burns <b>x</b> : Defective <b>y</b> : Stain</p>

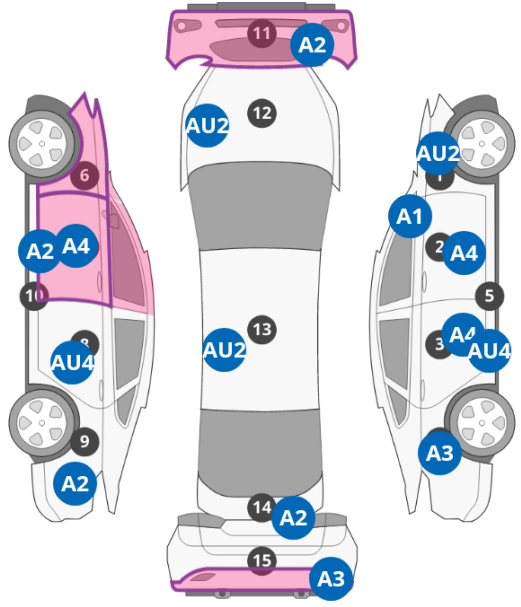
<p><b>A</b> : Scratch <b>AU</b> : Scratch &amp; Dent <b>B</b> : Modified <b>C</b> : Corrosion <b>G</b> : Stone chip <b>P</b> : Faded <b>S</b> : Rust <b>SC</b> : Rust &amp; Corrosion <b>U</b> : Dent <b>X</b> : Defective <b>Y</b> : Crack, Gap</p>
<p><b>Remarks</b> (R) Front Seat - Grime - Medium / (R) Front Trim - Grime - Small / Rear Seat - Grime - Medium / Trunk Room - Worn, Scratch, Cut, Crack - Small / (L) Front Trim - Grime - Small / (L) Front Seat - Grime - Medium / (R) Front Floor Mat - Missing - Yes / (L) Front Floor Mat - Missing - Yes / Mat Other - Missing - Yes / Ceiling - Grime - Minimal</p>	<p><b>Remarks</b> (L) Front Fender - Repair Traces - Yes / (R) Rear Door, Molding - Scratch - Large / (R) Rear Fender, Molding - Scratch - Medium / (R) Front Door, Molding - Scratch - Large / (R) Step, In-panel, Side Spoiler - Scratch &amp; Dent - Large / (R) Mirror - Scratch - Minimal / (R) Front Fender, Molding - Scratch &amp; Dent - Small / Bonnet, Headlight - Scratch &amp; Dent - Small / Front Bumper, Grille, Lamps - Repair mark - Yes / (L) Front Fender, Molding - Repair mark - Yes / (L) Front Door, Molding - Repair mark - Yes / (L) Front Door, Molding - Scratch - Large / (L) Rear Door, Molding - Scratch &amp; Dent - Large / (L) Rear Fender, Molding - Scratch - Small / (L) Step, In-panel, Side Spoiler - Scratch - Small / Trunk Hood, Rear Gate - Scratch - Small / Rear Bumper, Lamps, Panels - Repair mark - Yes / Rear Bumper, Lamps, Panels - Scratch - Medium / Roof - Scratch &amp; Dent - Small / Front Bumper, Grille, Lamps - Scratch - Small</p>

<p><b>Inspector Notes</b></p>
<p>with LTO plate/with spare tire/with jack No tools/with 1 key/No seat cover/No warranty booklet/reverse camera not working/front and rear floor mat missing/dome light issue front left fender traces of repair/front and rear bumper traces of repair/front left side door traces of repair /head units issue/aircon issue</p>
