General Information

Make	Toyota	Model	Vios
YOM	2025	Odo Meter Reading	5,899
Registration No.	NHU8724	Chassis No.	PA1B18F33R4277614
CC	1.3	Transmission	CVT
Fuel Type	Gas	Type of Body	Sedan
Colour	Blue

Body / Panel Condition

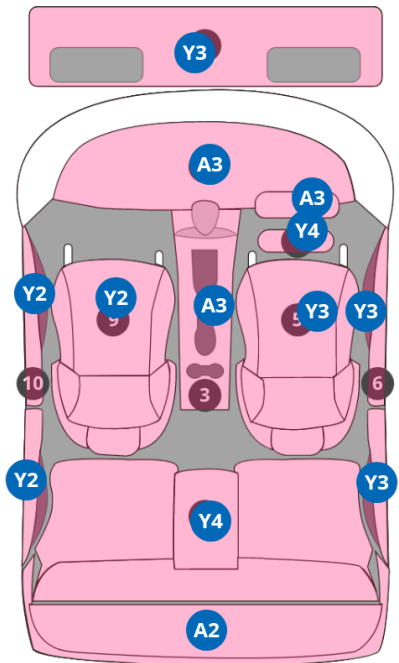
Interior Evaluation : E	Exterior Evaluation : E

<p>a : Cut, Fray d : Loose, Deformed k : Animal Hair s : Smell t : Cigarette Burns x : Defective y : Stain</p>

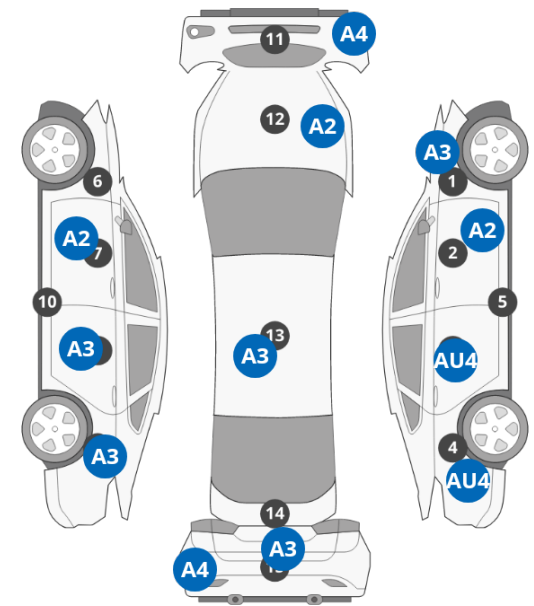
<p>A : Scratch AU : Scratch & Dent B : Modified C : Corrosion G : Stone chip P : Faded S : Rust SC : Rust & Corrosion U : Dent X : Defective Y : Crack, Gap</p>
Remarks (R) Front Seat - Grime - Medium / (R) Front Trim - Grime - Medium / Dashboard - Worn, Scratch, Cut, Crack - Medium / Rear Seat - Grime - Large / (R) Rear Trim - Grime - Medium / (L) Rear Trim - Grime - Small / (L) Front Trim - Grime - Small / (L) Front Seat - Grime - Small / (L) Front Floor Mat - Grime - Large / Steering Wheel - Worn, Peel, Crack - Medium / Ceiling - Grime - Medium / Console, Switchs, Vents - Worn, Scratch, Cut, Crack - Medium / Trunk Room - Worn, Scratch, Cut, Crack - Small	Remarks (L) Front Door, Molding - Scratch - Small / (L) Rear Door, Molding - Scratch - Medium / (L) Rear Fender, Molding - Scratch - Medium / Rear Bumper, Lamps, Panels - Scratch - Large / (R) Rear Fender, Molding - Scratch & Dent - Large / (R) Rear Door, Molding - Scratch & Dent - Large / (R) Front Door, Molding - Scratch - Small / (R) Front Fender, Molding - Scratch - Medium / Front Bumper, Grille, Lamps - Scratch - Large / Bonnet, Headlight - Scratch - Small / Roof - Scratch - Medium / Trunk Hood, Rear Gate - Scratch - Medium
