General Information

Make	Toyota	Model	Vios
YOM	2022	Odo Meter Reading	116,925
Registration No.	NID3998	Chassis No.	PA1B18F33N4185803
CC	1.3	Transmission	CVT
Fuel Type	Gas	Type of Body	Sedan
Colour	Silver

Body / Panel Condition

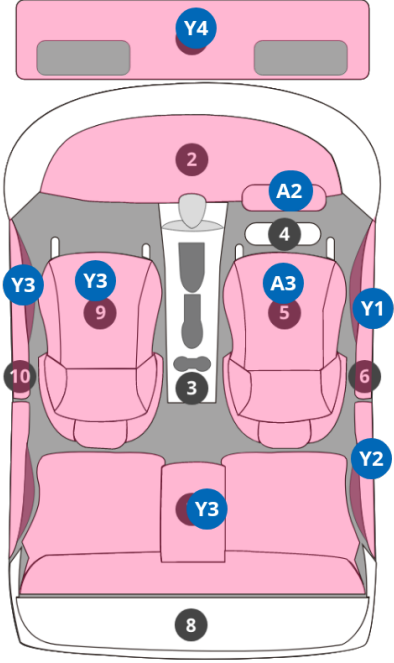
Interior Evaluation : C	Exterior Evaluation : D

<p>a : Cut, Fray d : Loose, Deformed k : Animal Hair s : Smell t : Cigarette Burns x : Defective y : Stain</p>

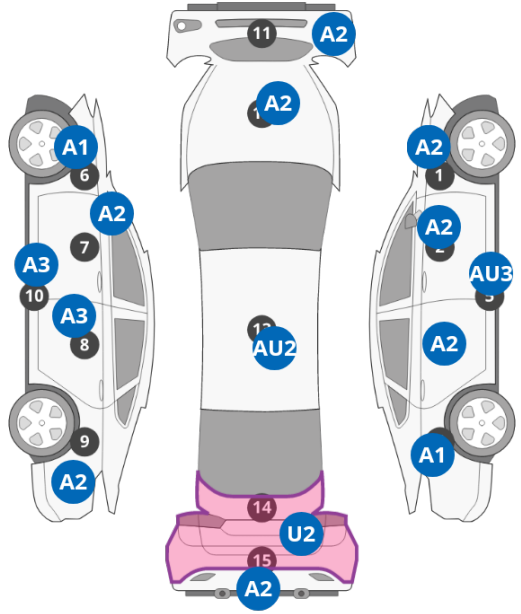
<p>A : Scratch AU : Scratch & Dent B : Modified C : Corrosion G : Stone chip P : Faded S : Rust SC : Rust & Corrosion U : Dent X : Defective Y : Crack, Gap</p>
<p>Remarks (R) Front Seat - Cut, Crack - Medium / Rear Seat - Grime - Medium / (R) Front Trim - Grime - Minimal / (R) Rear Trim - Grime - Small / (L) Front Trim - Grime - Medium / (L) Front Seat - Grime - Medium / Dashboard - Worn, Scratch, Cut, Crack - Minimal / Steering Wheel - Worn, Peel, Crack - Small / Ceiling - Grime - Large</p>	<p>Remarks (R) Front Door - Repair Traces - Yes / (R) Front Fender - Repair Traces - Yes / Bonnet - Repair Traces - Yes / (L) Front Fender - Repair Traces - Yes / (L) Front Door - Repair Traces - Yes / (L) Rear Door - Repair Traces - Yes / (L) Rear Fender - Repair Traces - Yes / Trunk Hood, Rear Gate - Repair Traces - Yes / (R) Rear Fender - Repair Traces - Yes / (R) Rear Door - Repair Traces - Yes / Roof - Repair Traces - Yes / Trunk Hood, Rear Gate - Repair mark - Yes / (L) Rear Door, Molding - Scratch - Medium / (L) Step, In-panel, Side Spoiler - Scratch - Medium / Trunk Hood, Rear Gate - Dent - Small / (R) Rear Fender, Molding - Scratch - Minimal / (R) Step, In-panel, Side Spoiler - Scratch & Dent - Medium / Front Bumper, Grille, Lamps - Scratch - Small / (L) Mirror - Scratch - Small / Bonnet, Headlight - Scratch - Small / (L) Rear Fender, Molding - Scratch - Small / (R) Front Door, Molding - Scratch - Small / (R) Rear Door, Molding - Scratch - Small / (L) Front Fender, Molding - Scratch - Minimal / (R) Front Fender, Molding - Scratch - Small / Roof - Scratch & Dent - Small / Rear Bumper, Lamps, Panels - Scratch - Small</p>
