General Information

Make	Toyota	Model	Rush
YOM	2022	Odo Meter Reading	15,261
Registration No.	DBF1964	Chassis No.	MHKE8FF3PMK035941
CC	1.5	Transmission	A/T
Fuel Type	Gas	Type of Body	SUV
Colour	Brown

Body / Panel Condition

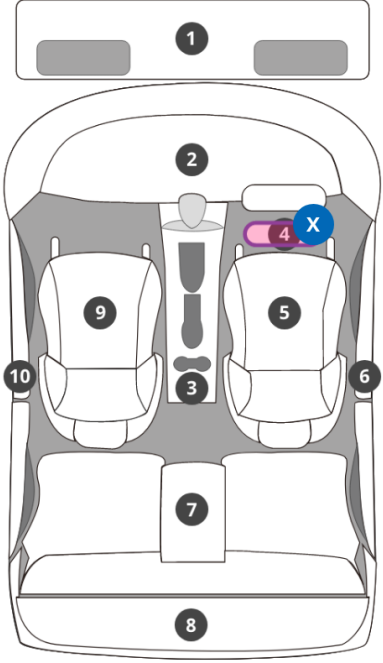
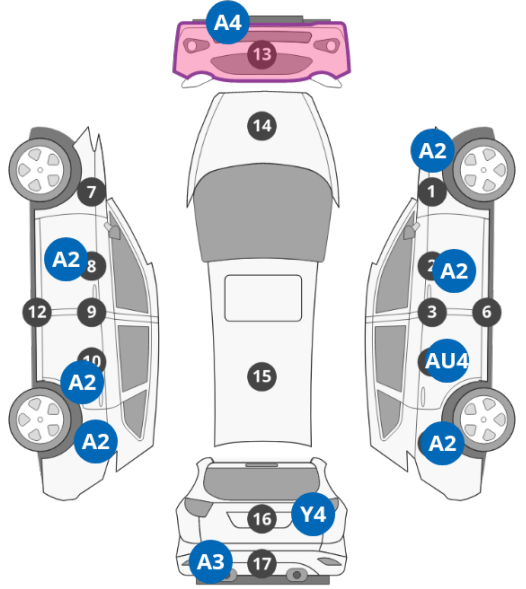
Interior Evaluation :	B	Exterior Evaluation :	D

<p>a : Cut, Fray d : Loose, Deformed k : Animal Hair s : Smell t : Cigarette Burns x : Defective y : Stain</p>		<p>A : Scratch AU : Scratch & Dent B : Modified C : Corrosion G : Stone chip P : Faded S : Rust SC : Rust & Corrosion U : Dent X : Defective Y : Crack, Gap</p>	
<p>Remarks Mat Other - Missing - Yes</p>		<p>Remarks (R) Rear Door, Molding - Scratch & Dent - Large / Front Bumper, Grille, Lamps - Repair mark - Yes / Front Bumper, Grille, Lamps - Scratch - Large / Trunk Hood, Rear Gate - Crack, Gap - Large / (L) Front Door, Molding - Scratch - Small / (L) Rear Door, Molding - Scratch - Small / (L) Rear Fender, Molding - Scratch - Small / Rear Bumper, Lamps, Panels - Scratch - Medium / (R) Front Door, Molding - Scratch - Small / (R) Front Fender, Molding - Scratch - Small / (R) Rear Fender, Molding - Scratch - Small</p>	
Frame Evaluation :	A	Functional Evaluation :	A
