## General Information

<b>Make</b>	Toyota	<b>Model</b>	Vios
<b>YOM</b>	2025	<b>Odo Meter Reading</b>	20,121
<b>Registration No.</b>	DBQ3151	<b>Chassis No.</b>	PA1B18F35R4269191
<b>CC</b>	1.3	<b>Transmission</b>	CVT
<b>Fuel Type</b>	Gas	<b>Type of Body</b>	Sedan
<b>Colour</b>	Red Mica Metallic

## Body / Panel Condition

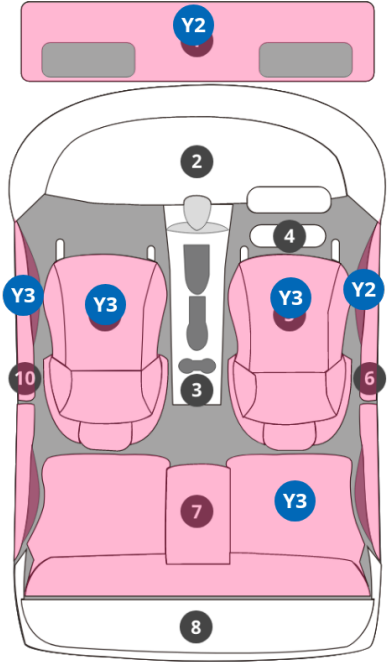
<b>Interior Evaluation :</b> <span style="float: right; color: red; font-weight: bold;">C</span>	<b>Exterior Evaluation :</b> <span style="float: right; color: red; font-weight: bold;">E</span>

<p><b>a</b> : Cut, Fray <b>d</b> : Loose, Deformed <b>k</b> : Animal Hair <b>s</b> : Smell <b>t</b> : Cigarette Burns <b>x</b> : Defective <b>y</b> : Stain</p>

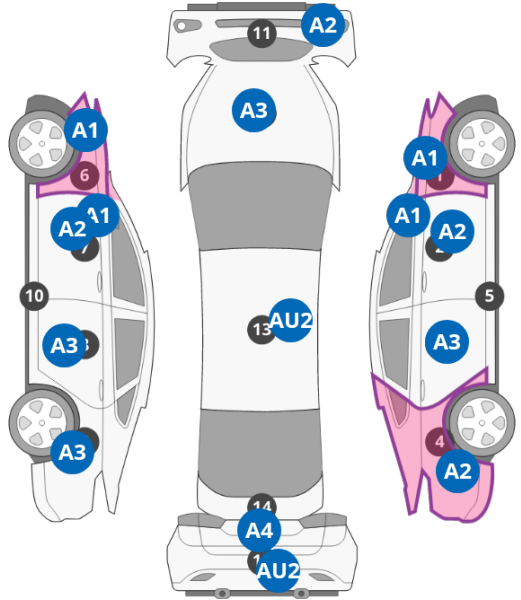
<p><b>A</b> : Scratch <b>AU</b> : Scratch &amp; Dent <b>B</b> : Modified <b>C</b> : Corrosion <b>G</b> : Stone chip <b>P</b> : Faded <b>S</b> : Rust <b>SC</b> : Rust &amp; Corrosion <b>U</b> : Dent <b>X</b> : Defective <b>Y</b> : Crack, Gap</p>
<p><b>Remarks</b> (R) Front Seat - Grime - Medium / (R) Front Trim - Grime - Small / Rear Seat - Grime - Medium / (L) Front Trim - Grime - Medium / (L) Front Seat - Grime - Medium / Ceiling - Grime - Small</p>	<p><b>Remarks</b> (R) Front Fender - Repair Traces - Yes / (L) Front Fender - Repair Traces - Yes / (R) Rear Fender - Repair Traces - Yes / Bonnet, Headlight - Scratch - Medium / (L) Mirror - Scratch - Minimal / (R) Front Fender, Molding - Scratch - Minimal / Front Bumper, Grille, Lamps - Scratch - Small / (L) Front Door, Molding - Scratch - Small / (L) Rear Door, Molding - Scratch - Medium / (L) Rear Fender, Molding - Scratch - Medium / Trunk Hood, Rear Gate - Scratch - Large / Rear Bumper, Lamps, Panels - Scratch &amp; Dent - Small / (R) Rear Door, Molding - Scratch - Medium / (R) Rear Fender, Molding - Scratch - Small / (R) Front Door, Molding - Scratch - Small / (R) Mirror - Scratch - Minimal / (L) Front Fender, Molding - Scratch - Minimal / Roof - Scratch &amp; Dent - Small / (L) Front Fender, Molding - Repair mark - Yes / (R) Front Fender, Molding - Repair mark - Yes / (R) Rear Fender, Molding - Repair mark - Yes</p>
