General Information

Make	Toyota	Model	Vios
YOM	2025	Odo Meter Reading	2,977
Registration No.	DCA4090	Chassis No.	PA1B18F39S4292642
CC	1.3	Transmission	CVT
Fuel Type	Gas	Type of Body	Sedan
Colour	Black

Body / Panel Condition

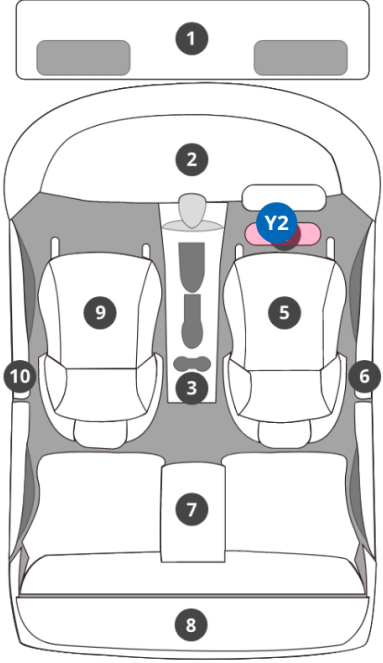
Interior Evaluation : A	Exterior Evaluation : C

<p>a : Cut, Fray d : Loose, Deformed k : Animal Hair s : Smell t : Cigarette Burns x : Defective y : Stain</p>

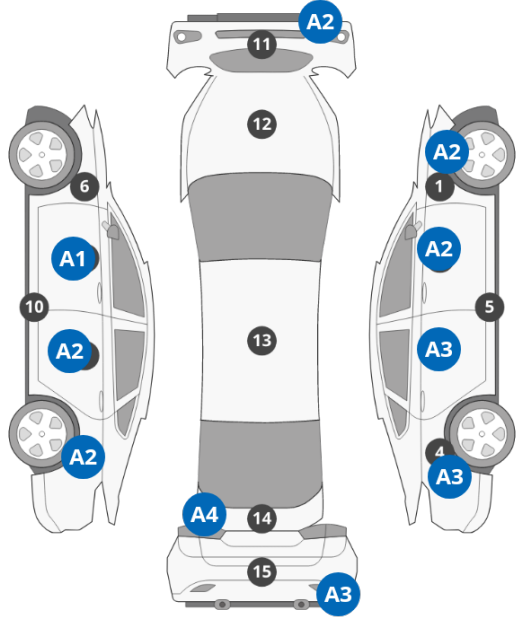
<p>A : Scratch AU : Scratch & Dent B : Modified C : Corrosion G : Stone chip P : Faded S : Rust SC : Rust & Corrosion U : Dent X : Defective Y : Crack, Gap</p>
Remarks (L) Front Floor Mat - Grime - Small	Remarks (R) Rear Fender, Molding - Scratch - Medium / (R) Rear Door, Molding - Scratch - Medium / Trunk Hood, Rear Gate - Scratch - Large / Rear Bumper, Lamps, Panels - Scratch - Medium / (R) Front Door, Molding - Scratch - Small / (R) Front Fender, Molding - Scratch - Small / (L) Front Door, Molding - Scratch - Minimal / (L) Rear Door, Molding - Scratch - Small / (L) Rear Fender, Molding - Scratch - Small / Front Bumper, Grille, Lamps - Scratch - Small
Frame Evaluation : A	Functional Evaluation : B
Remarks Defects not found	Remarks Battery - Weak - Yes
