## General Information

| Make | Toyota | Model | Wigo |

## Body / Panel Condition

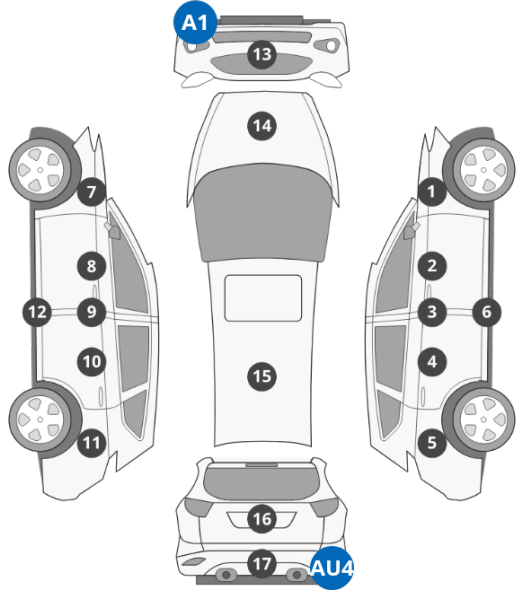
| Interior Evaluation : <span style="color: red; font-weight: bold;">A</span> | Exterior Evaluation : <span style="color: red; font-weight: bold;">C</span> |
| <b>Remarks</b><br>Defects not found | <b>Remarks</b><br>Rear Bumper, Lamps, Panels - Scratch & Dent - Large / Front Bumper, Grille, Lamps - Scratch - Minimal |

with warranty booklet/ no tools and jack / with spare tire/ with LTO plate/ broken right tail light/
