General Information

Make	Toyota	Model	Vios
YOM	2025	Odo Meter Reading	4,033
Registration No.	DCA3819	Chassis No.	PA1B18F32S4292725
CC	1.3	Transmission	CVT
Fuel Type	Gas	Type of Body	Sedan
Colour	Silver

Body / Panel Condition

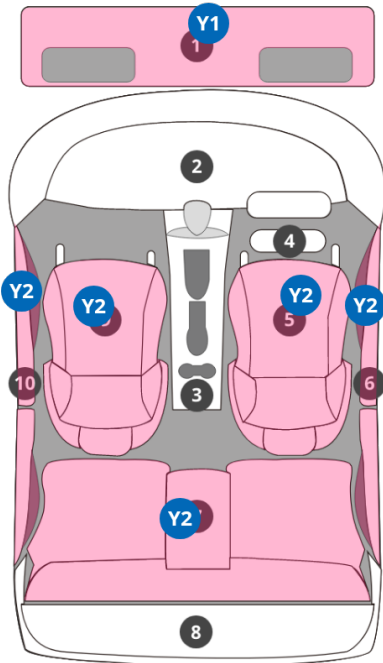
Interior Evaluation : B	Exterior Evaluation : B

<p>a : Cut, Fray d : Loose, Deformed k : Animal Hair s : Smell t : Cigarette Burns x : Defective y : Stain</p>

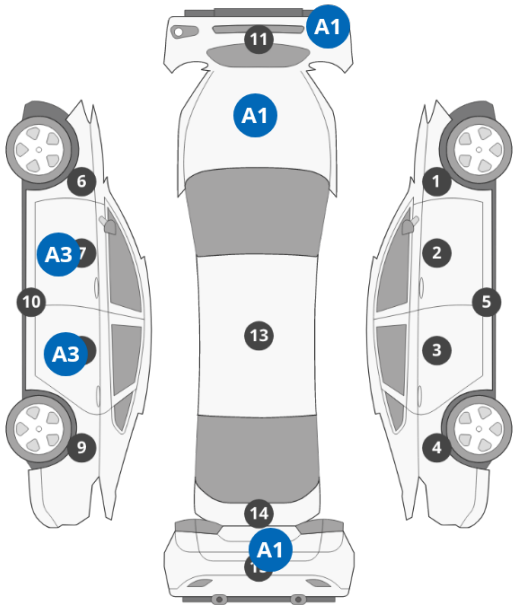
<p>A : Scratch AU : Scratch & Dent B : Modified C : Corrosion G : Stone chip P : Faded S : Rust SC : Rust & Corrosion U : Dent X : Defective Y : Crack, Gap</p>
<p>Remarks (R) Front Seat - Grime - Small / (R) Front Trim - Grime - Small / Rear Seat - Grime - Small / (L) Front Trim - Grime - Small / (L) Front Seat - Grime - Small / Ceiling - Grime - Minimal</p>	<p>Remarks Trunk Hood, Rear Gate - Scratch - Minimal / (L) Rear Door, Molding - Scratch - Medium / (L) Front Door, Molding - Scratch - Medium / Bonnet, Headlight - Scratch - Minimal / Front Bumper, Grille, Lamps - Scratch - Minimal</p>
Frame Evaluation : A	Functional Evaluation : B
<p>Remarks Defects not found</p>	<p>Remarks Battery - Weak - Yes</p>
