General Information

Make	Toyota	Model	Veloz
YOM	2023	Odo Meter Reading	29,087
Registration No.	NFC7231	Chassis No.	MHFAB1BY0P3065385
CC	1.5	Transmission	CVT
Fuel Type	Gas	Type of Body	SUV
Colour	Black

Body / Panel Condition

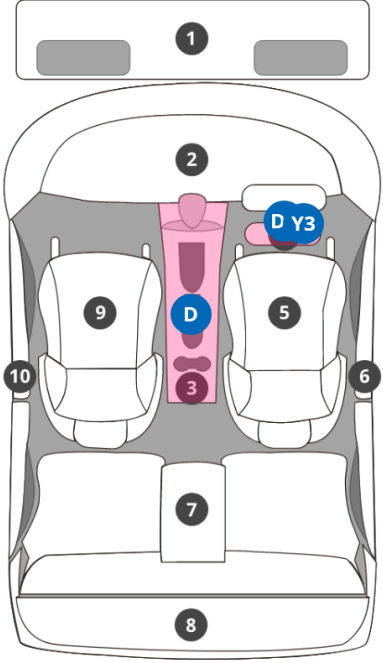
Interior Evaluation : C	Exterior Evaluation : E

<p>a : Cut, Fray d : Loose, Deformed k : Animal Hair s : Smell t : Cigarette Burns x : Defective y : Stain</p>

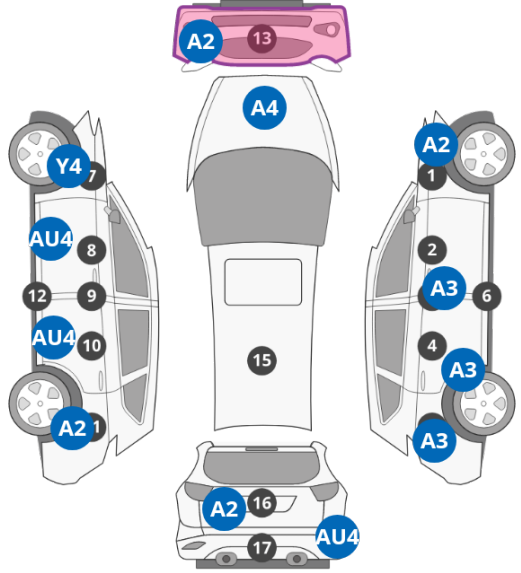
<p>A : Scratch AU : Scratch & Dent B : Modified C : Corrosion G : Stone chip P : Faded S : Rust SC : Rust & Corrosion U : Dent X : Defective Y : Crack, Gap</p>
<p>Remarks Console, Switches, Vents - Traces of Adhesive Tape - Yes / (L) Front Floor Mat - Worked - Large / (R) Front Floor Mat - Grime - Medium</p>	<p>Remarks (R) Step - Repair Traces - Yes / (L) Front Fender - Repair Traces - Yes / (L) Step - Repair Traces - Yes / Rear Bumper, Lamps, Panels - Scratch & Dent - Large / Trunk Hood, Rear Gate - Scratch - Small / (L) Rear Fender, Molding - Scratch - Small / (L) Rear Door, Molding - Scratch & Dent - Large / (L) Front Door, Molding - Scratch & Dent - Large / (L) Front Fender, Molding - Crack, Gap - Large / Bonnet, Headlight - Scratch - Large / (R) Rear Door, Molding - Scratch - Medium / (R) Rear Fender, Molding - Scratch - Medium / (R) Front Door, Molding - Scratch - Medium / Front Bumper, Grille, Lamps - Repair mark - Yes / Front Bumper, Grille, Lamps - Scratch - Small / (R) Front Fender, Molding - Scratch - Small</p>
