General Information

Make	Toyota	Model	Vios
YOM	2024	Odo Meter Reading	40,148
Registration No.	NFF6722	Chassis No.	PA1B18F36P4234995
CC	1.3	Transmission	CVT
Fuel Type	Gas	Type of Body	Sedan
Colour	Red

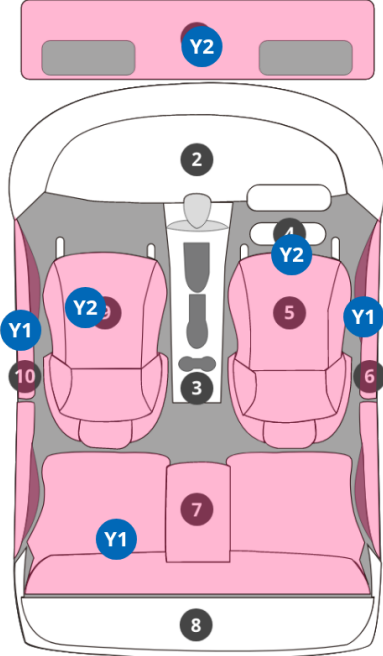
Interior Evaluation : A	Exterior Evaluation : E

<p>a : Cut, Fray d : Loose, Deformed k : Animal Hair s : Smell t : Cigarette Burns x : Defective y : Stain</p>

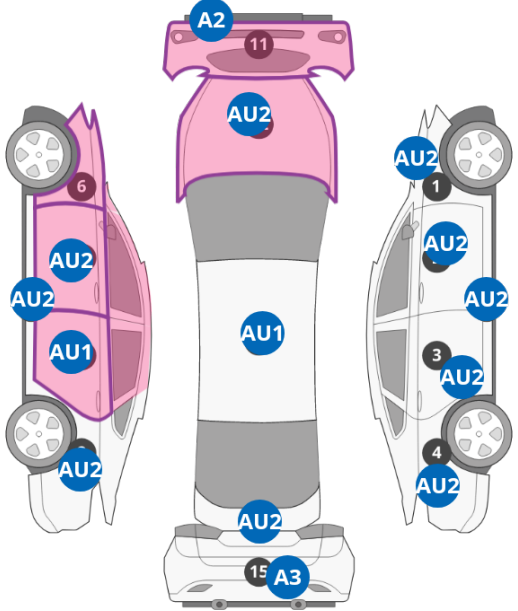
<p>A : Scratch AU : Scratch & Dent B : Modified C : Corrosion G : Stone chip P : Faded S : Rust SC : Rust & Corrosion U : Dent X : Defective Y : Crack, Gap</p>
<p>Remarks (L) Front Seat - Grime - Small / (R) Front Seat - Grime - Small / Rear Seat - Grime - Minimal / (L) Front Trim - Grime - Minimal / (R) Front Trim - Grime - Minimal / Ceiling - Grime - Small</p>	<p>Remarks Bonnet - Repair Traces - Yes / (L) Front Door - Repair Traces - Yes / (L) Step - Repair Traces - Yes / (L) Front Door, Molding - Repair mark - Yes / (L) Rear Door, Molding - Repair mark - Yes / (L) Front Fender, Molding - Repair mark - Yes / Bonnet, Headlight - Repair mark - Yes / Roof - Scratch & Dent - Minimal / (L) Rear Door, Molding - Scratch & Dent - Minimal / (L) Front Door, Molding - Scratch & Dent - Small / (L) Step, In-panel, Side Spoiler - Scratch & Dent - Small / Front Bumper, Grille, Lamps - Repair mark - Yes / Bonnet, Headlight - Scratch & Dent - Small / Front Bumper, Grille, Lamps - Scratch - Small / (R) Front Fender, Molding - Scratch & Dent - Small / (R) Step, In-panel, Side Spoiler - Scratch & Dent - Small / (R) Front Door, Molding - Scratch & Dent - Small / (R) Rear Door, Molding - Scratch & Dent - Small / (R) Rear Fender, Molding - Scratch & Dent - Small / Trunk Hood, Rear Gate - Scratch & Dent - Small / Rear Bumper, Lamps, Panels - Scratch - Medium / (L) Rear Fender, Molding - Scratch & Dent - Small</p>
