General Information

Make	Toyota	Model	Vios
YOM	2025	Odo Meter Reading	9,113
Registration No.	NJC8534	Chassis No.	PA1B18F30S4288723
CC	1.3	Transmission	CVT
Fuel Type	Gas	Type of Body	Sedan
Colour	Red Mica Metallic

Body / Panel Condition

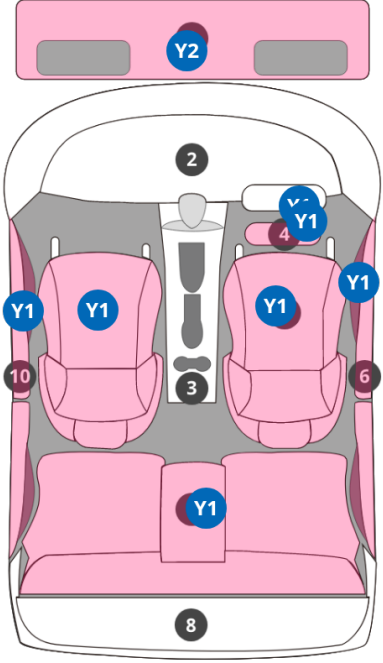
Interior Evaluation : A	Exterior Evaluation : D

<p>a : Cut, Fray d : Loose, Deformed k : Animal Hair s : Smell t : Cigarette Burns x : Defective y : Stain</p>

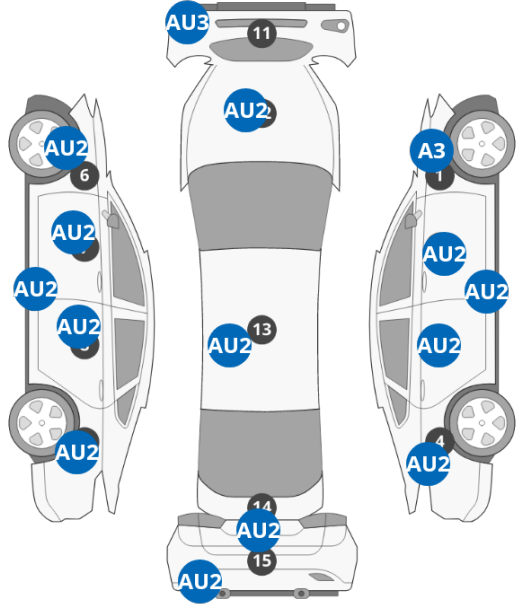
<p>A : Scratch AU : Scratch & Dent B : Modified C : Corrosion G : Stone chip P : Faded S : Rust SC : Rust & Corrosion U : Dent X : Defective Y : Crack, Gap</p>
<p>Remarks (L) Front Seat - Grime - Minimal / (R) Front Seat - Grime - Minimal / (L) Front Floor Mat - Grime - Minimal / (R) Front Floor Mat - Grime - Minimal / (R) Front Trim - Grime - Minimal / (L) Front Trim - Grime - Minimal / Rear Seat - Grime - Minimal / Ceiling - Grime - Small</p>	<p>Remarks Roof - Scratch & Dent - Small / (L) Rear Door, Molding - Scratch & Dent - Small / (L) Front Door, Molding - Scratch & Dent - Small / (L) Front Fender, Molding - Scratch & Dent - Small / Front Bumper, Grille, Lamps - Scratch & Dent - Medium / (L) Step, In-panel, Side Spoiler - Scratch & Dent - Small / Bonnet, Headlight - Scratch & Dent - Small / (R) Front Fender, Molding - Scratch - Medium / (R) Front Door, Molding - Scratch & Dent - Small / (R) Rear Door, Molding - Scratch & Dent - Small / (R) Step, In-panel, Side Spoiler - Scratch & Dent - Small / (R) Rear Fender, Molding - Scratch & Dent - Small / Trunk Hood, Rear Gate - Scratch & Dent - Small / Rear Bumper, Lamps, Panels - Scratch & Dent - Small / (L) Rear Fender, Molding - Scratch & Dent - Small</p>
