General Information

Make	Toyota	Model	Avanza
YOM	2025	Odo Meter Reading	5,796
Registration No.	NKQ8846	Chassis No.	MHFAA1BY8S0042742
CC	1.3	Transmission	CVT
Fuel Type	Gas	Type of Body	Wagon
Colour	Green

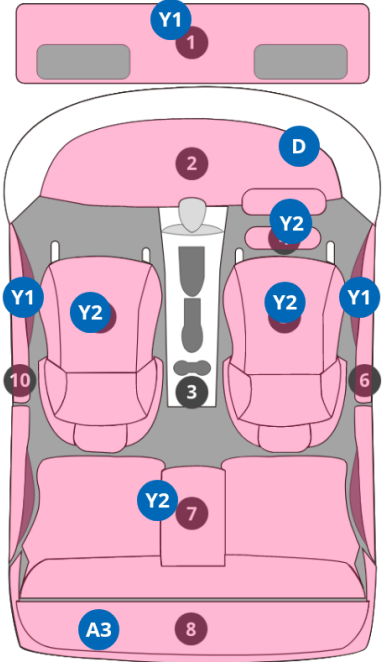
Interior Evaluation : B	Exterior Evaluation : D

<p>a : Cut, Fray d : Loose, Deformed k : Animal Hair s : Smell t : Cigarette Burns x : Defective y : Stain</p>

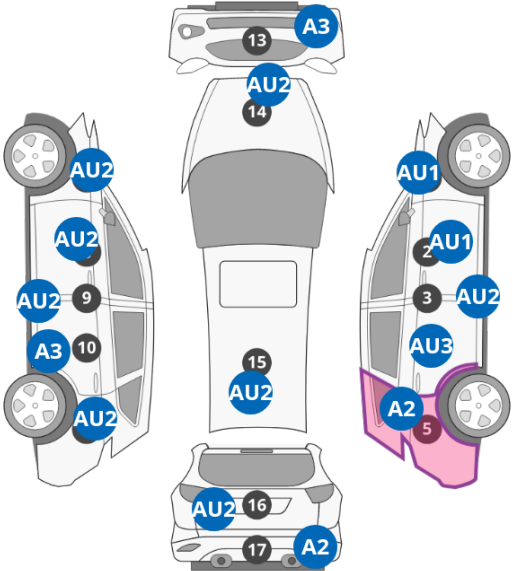
<p>A : Scratch AU : Scratch & Dent B : Modified C : Corrosion G : Stone chip P : Faded S : Rust SC : Rust & Corrosion U : Dent X : Defective Y : Crack, Gap</p>
<p>Remarks (L) Front Floor Mat - Grime - Medium / (R) Front Floor Mat - Grime - Small / (L) Front Seat - Grime - Small / (R) Front Seat - Grime - Small / Rear Seat - Grime - Small / Ceiling - Grime - Minimal / (L) Front Trim - Grime - Minimal / (R) Front Trim - Grime - Minimal / Trunk Room - Worn, Scratch, Cut, Crack - Medium</p>	<p>Remarks (R) Rear Fender - Repair Traces - Yes / (L) Front Door, Molding - Scratch & Dent - Small / Bonnet, Headlight - Scratch & Dent - Small / (L) Front Fender, Molding - Scratch & Dent - Small / (L) Rear Fender, Molding - Scratch & Dent - Small / Trunk Hood, Rear Gate - Scratch & Dent - Small / Rear Bumper, Lamps, Panels - Scratch - Small / (R) Rear Fender, Molding - Repair mark - Yes / (R) Rear Door, Molding - Scratch & Dent - Medium / (R) Step, In-panel, Side Spoiler - Scratch & Dent - Small / (R) Front Door, Molding - Scratch & Dent - Minimal / (R) Front Fender, Molding - Scratch & Dent - Minimal / Front Bumper, Grille, Lamps - Scratch - Medium / Roof - Scratch & Dent - Small / (R) Rear Fender, Molding - Scratch - Small / (L) Step, In-panel, Side Spoiler - Scratch & Dent - Small / (L) Rear Door, Molding - Scratch - Medium</p>
