## General Information

| Make | Toyota | Model | Wigo |
| YOM | 2021 | Mileage | 29,666 |
| Registration No. | NGO5348 | Chassis No. | MHKA4DF5FLJ046874 |

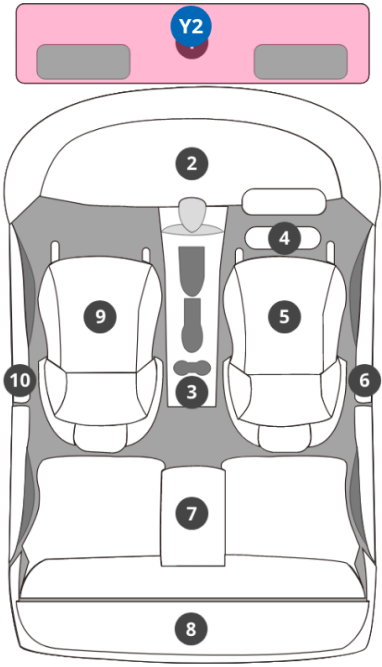
| <b>Interior Evaluation :</b> <span style="color: red; font-weight: bold;">A</span> | <b>Exterior Evaluation :</b> <span style="color: red; font-weight: bold;">D</span> |
| <b>Remarks</b><br>Ceiling - Grime - Small | <b>Remarks</b><br>(R) Front Fender, Molding - Scratch & Dent - Large / Front Bumper, Grille, Lamps - Scratch & Dent - Large / (R) Step, In-panel, Side Spoiler - Scratch & Dent - Small / (R) Rear Fender, Molding - Scratch & Dent - Small / Rear Bumper, Lamps, Panels - Scratch & Dent - Small / (L) Rear Fender, Molding - Scratch - Small / (L) Rear Door, Molding - Dent - Small / (L) Front Door, Molding - Scratch - Small / (R) Front Door, Molding - Scratch & Dent - Minimal / (R) Rear Door, Molding - Scratch & Dent - Large |
