General Information

Make	Toyota	Model	Veloz
YOM	2025	Odo Meter Reading	20,699
Registration No.	CCG6315	Chassis No.	MHFAB1BY9R315560
CC	1.5	Transmission	CVT
Fuel Type	Gas	Type of Body	Wagon
Colour	Red Mica Metallic

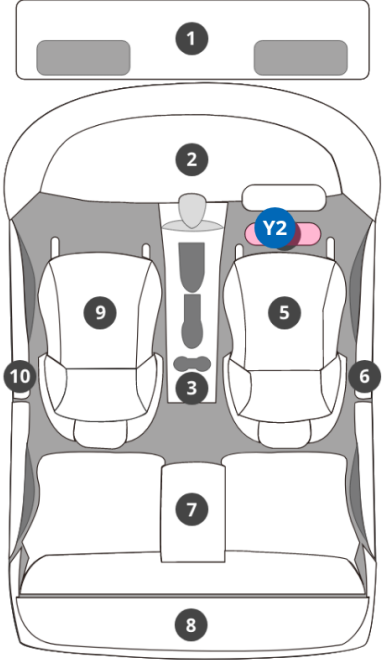
Interior Evaluation : A	Exterior Evaluation : D

<p>a : Cut, Fray d : Loose, Deformed k : Animal Hair s : Smell t : Cigarette Burns x : Defective y : Stain</p>

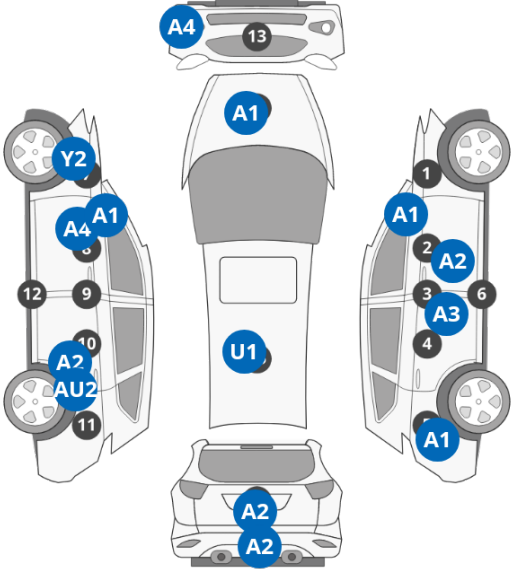
<p>A : Scratch AU : Scratch & Dent B : Modified C : Corrosion G : Stone chip P : Faded S : Rust SC : Rust & Corrosion U : Dent X : Defective Y : Crack, Gap</p>
<p>Remarks (L) Front Floor Mat - Grime - Small</p>	<p>Remarks (R) Mirror - Scratch - Minimal / (R) Front Door, Molding - Scratch - Small / (R) Rear Door, Molding - Scratch - Medium / (R) Rear Fender, Molding - Scratch - Minimal / Trunk Hood, Rear Gate - Scratch - Small / Rear Bumper, Lamps, Panels - Scratch - Small / (L) Rear Door, Molding - Scratch - Small / (L) Rear Fender, Molding - Scratch & Dent - Small / (L) Front Door, Molding - Scratch - Large / (L) Mirror - Scratch - Minimal / (L) Front Fender, Molding - Crack, Gap - Small / Front Bumper, Grille, Lamps - Scratch - Large / Bonnet, Headlight - Scratch - Minimal / Roof - Dent - Minimal</p>

<p>Inspector Notes</p>
<p>With Lto plate, with warranty booklet, with spare tire and jack, no tools, scratches on headlights and taillights</p>
