General Information

Make	Toyota	Model	Vios
YOM	2023	Odo Meter Reading	21,699
Registration No.	BAF4663	Chassis No.	PA1B18F36P4223849
CC	1.3	Transmission	CVT
Fuel Type	Gas	Type of Body	Sedan
Colour	Black

Body / Panel Condition

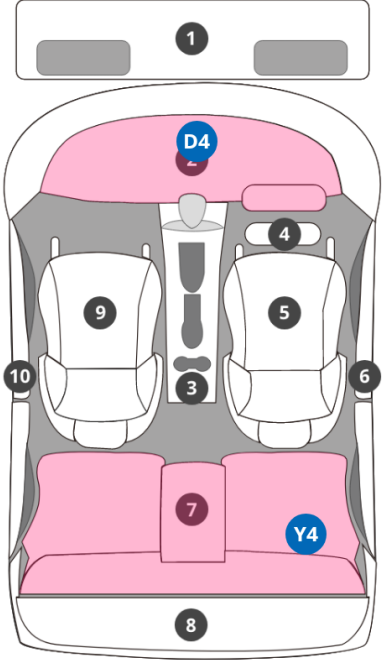
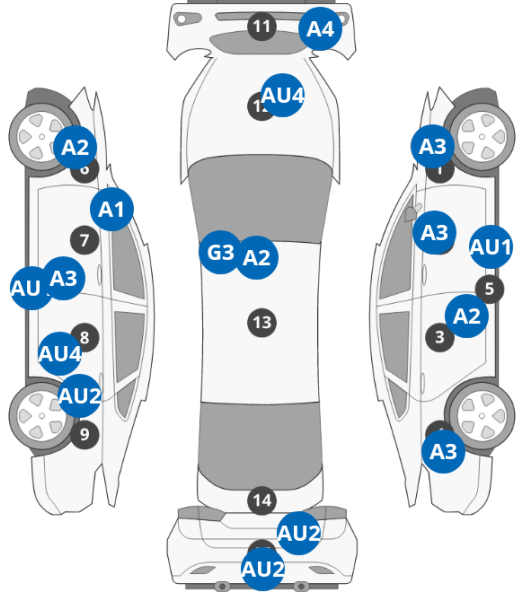
Interior Evaluation :	C	Exterior Evaluation :	E

<p>a : Cut, Fray d : Loose, Deformed k : Animal Hair s : Smell t : Cigarette Burns x : Defective y : Stain</p>		<p>A : Scratch AU : Scratch & Dent B : Modified C : Corrosion G : Stone chip P : Faded S : Rust SC : Rust & Corrosion U : Dent X : Defective Y : Crack, Gap</p>	
<p>Remarks Rear Seat - Grime - Large / Dashboard - Loose, Deformed - Large</p>		<p>Remarks Bonnet - Repair Traces - Yes / (R) Front Fender, Molding - Scratch - Medium / (R) Front Door, Molding - Scratch - Medium / (R) Step, In-panel, Side Spoiler - Scratch & Dent - Minimal / (R) Rear Door, Molding - Scratch - Small / (R) Rear Fender, Molding - Scratch - Medium / Roof - Scratch - Small / Rear Bumper, Lamps, Panels - Scratch & Dent - Small / Trunk Hood, Rear Gate - Scratch & Dent - Small / (L) Rear Fender, Molding - Scratch & Dent - Small / (L) Rear Door, Molding - Scratch & Dent - Large / (L) Mirror - Scratch - Minimal / (L) Step, In-panel, Side Spoiler - Scratch & Dent - Minimal / (L) Front Door, Molding - Scratch - Medium / (L) Front Fender, Molding - Scratch - Small / Bonnet, Headlight - Scratch & Dent - Large / Front Bumper, Grille, Lamps - Scratch - Large / Front Windshield - Scratch, Stone chip - Medium</p>
