General Information

Make	Toyota	Model	Vios
YOM	2024	Odo Meter Reading	34,285
Registration No.	CAZ7243	Chassis No.	PA1B18F30P4229632
CC	1.3	Transmission	CVT
Fuel Type	Gas	Type of Body	Sedan
Colour	Green

Body / Panel Condition

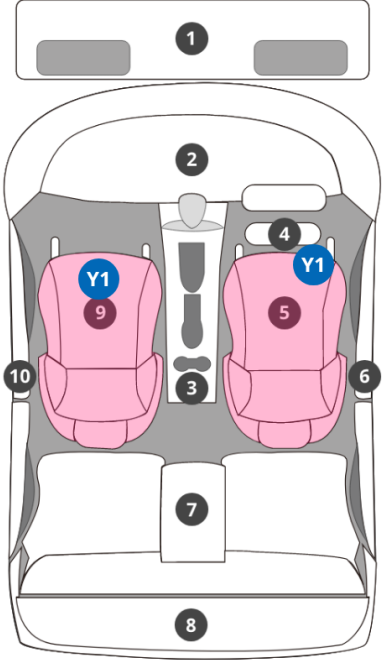
<p>a : Cut, Fray d : Loose, Deformed k : Animal Hair s : Smell t : Cigarette Burns x : Defective y : Stain</p>

<p>A : Scratch AU : Scratch & Dent B : Modified C : Corrosion G : Stone chip P : Faded S : Rust SC : Rust & Corrosion U : Dent X : Defective Y : Crack, Gap</p>
<p>Remarks (R) Front Seat - Grime - Minimal / (L) Front Seat - Grime - Minimal</p>	<p>Remarks (R) Front Fender, Molding - Scratch & Dent - Minimal / (R) Mirror - Scratch - Minimal / (R) Front Door, Molding - Scratch - Small / (R) Step, In-panel, Side Spoiler - Scratch & Dent - Large / (R) Rear Door, Molding - Scratch & Dent - Small / (R) Rear Fender, Molding - Scratch - Minimal / Rear Bumper, Lamps, Panels - Scratch & Dent - Small / Trunk Hood, Rear Gate - Scratch & Dent - Large / (L) Rear Fender, Molding - Dent - Minimal / (L) Rear Door, Molding - Scratch & Dent - Minimal / (L) Front Door, Molding - Scratch & Dent - Minimal / Front Bumper, Grille, Lamps - Scratch - Medium / Bonnet, Headlight - Scratch - Minimal</p>
