General Information

Make	Toyota	Model	Vios
YOM	2023	Odo Meter Reading	8,267
Registration No.	CCA2608	Chassis No.	PA1B18F35P4217427
CC	1.3	Transmission	CVT
Fuel Type	Gas	Type of Body	Sedan
Colour	Blackish Red Mica

Body / Panel Condition

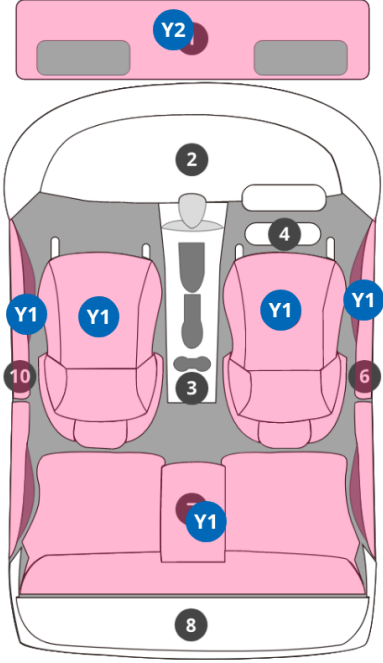
Interior Evaluation : A	Exterior Evaluation : C

<p>a : Cut, Fray d : Loose, Deformed k : Animal Hair s : Smell t : Cigarette Burns x : Defective y : Stain</p>

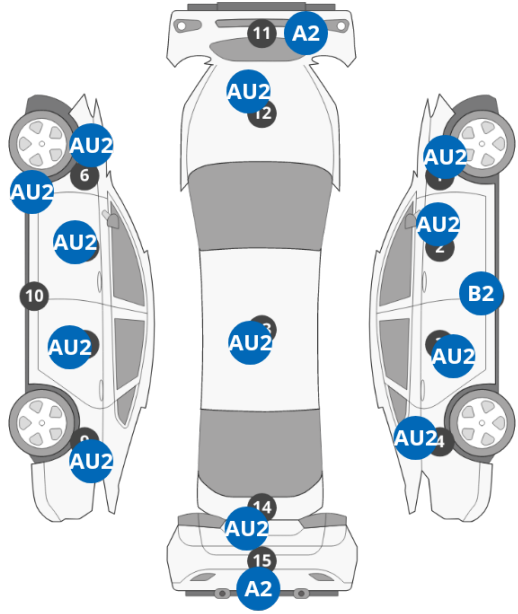
<p>A : Scratch AU : Scratch & Dent B : Modified C : Corrosion G : Stone chip P : Faded S : Rust SC : Rust & Corrosion U : Dent X : Defective Y : Crack, Gap</p>
<p>Remarks (L) Front Seat - Grime - Minimal / (R) Front Seat - Grime - Minimal / (L) Front Trim - Grime - Minimal / (R) Front Trim - Grime - Minimal / Rear Seat - Grime - Minimal / Ceiling - Grime - Small</p>	<p>Remarks Bonnet, Headlight - Scratch & Dent - Small / (L) Front Fender, Molding - Scratch & Dent - Small / (L) Front Door, Molding - Scratch & Dent - Small / (L) Rear Door, Molding - Scratch & Dent - Small / (L) Step, In-panel, Side Spoiler - Scratch & Dent - Small / (L) Rear Fender, Molding - Scratch & Dent - Small / Trunk Hood, Rear Gate - Scratch & Dent - Small / Rear Bumper, Lamps, Panels - Scratch - Small / Roof - Scratch & Dent - Small / (R) Rear Fender, Molding - Scratch & Dent - Small / (R) Front Door, Molding - Scratch & Dent - Small / (R) Rear Door, Molding - Scratch & Dent - Small / (R) Front Fender, Molding - Scratch & Dent - Small / (R) Step, In-panel, Side Spoiler - Modified - Small / Front Bumper, Grille, Lamps - Scratch - Small</p>

<p>Inspector Notes</p>
<p>with LTO plate, with spare tire, with warranty booklet, with spare key, with jack, no tools, horn issue, scratches on taillight and headlight.</p>
