General Information

Make	Toyota	Model	Vios
YOM	2025	Odo Meter Reading	8,870
Registration No.	CCQ1680	Chassis No.	PA1B18F30S429186
CC	1.3	Transmission	CVT
Fuel Type	Gas	Type of Body	Sedan
Colour	Red

Body / Panel Condition

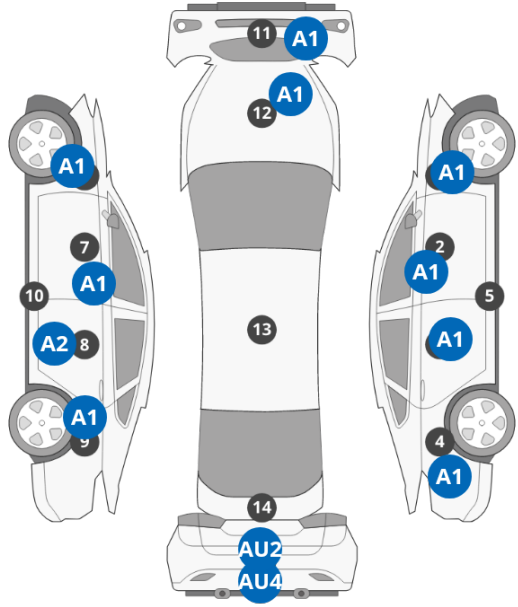
<p>A : Scratch AU : Scratch & Dent B : Modified C : Corrosion G : Stone chip P : Faded S : Rust SC : Rust & Corrosion U : Dent X : Defective Y : Crack, Gap</p>
Remarks Defects not found	Remarks (R) Front Fender, Molding - Scratch - Minimal / (R) Front Door, Molding - Scratch - Minimal / (R) Rear Door, Molding - Scratch - Minimal / (R) Rear Fender, Molding - Scratch - Minimal / Rear Bumper, Lamps, Panels - Scratch & Dent - Large / Trunk Hood, Rear Gate - Scratch & Dent - Small / (L) Rear Fender, Molding - Scratch - Minimal / (L) Rear Door, Molding - Scratch - Small / (L) Front Door, Molding - Scratch - Minimal / (L) Front Fender, Molding - Scratch - Minimal / Bonnet, Headlight - Scratch - Minimal / Front Bumper, Grille, Lamps - Scratch - Minimal
