General Information

Make	Toyota	Model	Vios
YOM	2024	Odo Meter Reading	55,956
Registration No.	CCC6539	Chassis No.	PA1B18F3XR425100
CC	1.3	Transmission	CVT
Fuel Type	Gas	Type of Body	Sedan
Colour	Blackish Red Mica

Body / Panel Condition

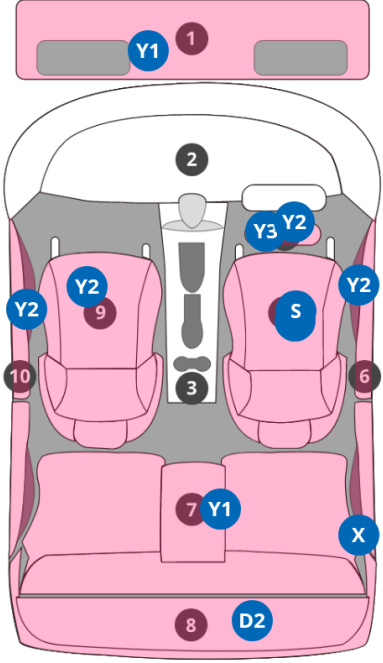
Interior Evaluation : B	Exterior Evaluation : E

<p>a : Cut, Fray d : Loose, Deformed k : Animal Hair s : Smell t : Cigarette Burns x : Defective y : Stain</p>

<p>A : Scratch AU : Scratch & Dent B : Modified C : Corrosion G : Stone chip P : Faded S : Rust SC : Rust & Corrosion U : Dent X : Defective Y : Crack, Gap</p>
<p>Remarks (L) Front Floor Mat - Grime - Medium / (L) Front Seat - Grime - Small / (R) Front Seat - Grime - Minimal / Rear Seat - Grime - Minimal / Mat Other - Grime - Small / (L) Front Trim - Grime - Small / (R) Front Trim - Grime - Small / Ceiling - Grime - Minimal / Trunk Room - Loose, Deformed - Small / Trim Other - Missing - Yes / Overall Interior - Smell - Yes</p>	<p>Remarks (R) Front Fender - Repair Traces - Yes / (L) Front Fender - Repair Traces - Yes / (L) Front Door - Repair Traces - Yes / Roof - Scratch & Dent - Small / (L) Rear Door, Molding - Scratch & Dent - Small / (L) Front Door, Molding - Scratch - Medium / (L) Front Fender, Molding - Scratch & Dent - Small / Bonnet, Headlight - Scratch & Dent - Medium / Front Bumper, Grille, Lamps - Scratch - Medium / (R) Front Fender, Molding - Scratch & Dent - Small / (R) Front Door, Molding - Scratch & Dent - Small / (R) Rear Door, Molding - Scratch & Dent - Small / (R) Step, In-panel, Side Spoiler - Scratch & Dent - Small / (R) Rear Fender, Molding - Scratch & Dent - Large / Trunk Hood, Rear Gate - Scratch & Dent - Small / (L) Rear Fender, Molding - Scratch & Dent - Small / Rear Bumper, Lamps, Panels - Scratch - Small / (L) Step, In-panel, Side Spoiler - Scratch & Dent - Small</p>

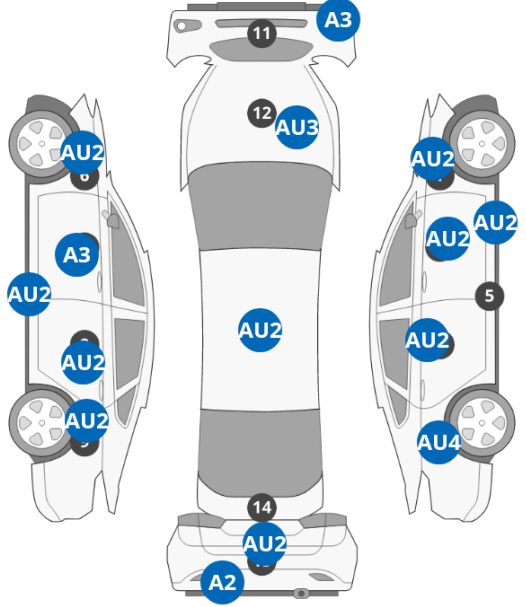
<p>Inspector Notes</p>
<p>with LTO plate, with reverse camera, no spare key, no spare tire, no tools and jack, no warranty and manual booklet, partially missing trunk interior, scratches on taillight, issue on headlight lens.</p>
