General Information

Make	Toyota	Model	Wigo
YOM	2021	Odo Meter Reading	69,639
Registration No.	BAE8532	Chassis No.	MHKA4DF5FMJ057211
CC	1.0	Transmission	A/T
Fuel Type	Gas	Type of Body	Hatchback
Colour	White

Body / Panel Condition

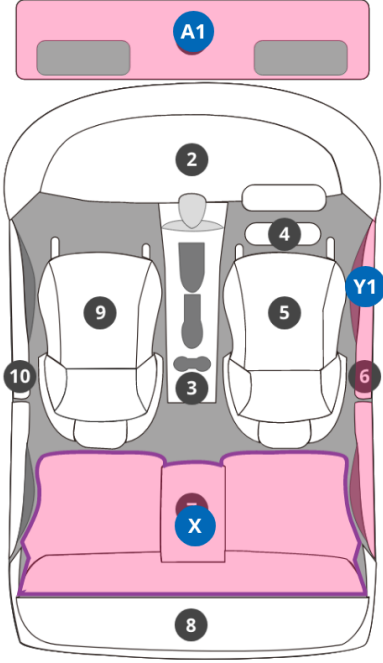
Interior Evaluation : C	Exterior Evaluation : C

<p>a : Cut, Fray d : Loose, Deformed k : Animal Hair s : Smell t : Cigarette Burns x : Defective y : Stain</p>

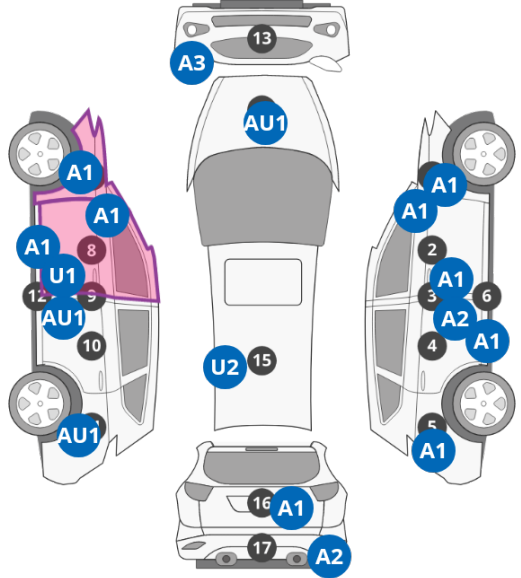
<p>A : Scratch AU : Scratch & Dent B : Modified C : Corrosion G : Stone chip P : Faded S : Rust SC : Rust & Corrosion U : Dent X : Defective Y : Crack, Gap</p>
<p>Remarks Rear Seat Head Rest - Partially Missing - Yes / (R) Front Trim - Grime - Minimal / Ceiling - Cut, Crack - Minimal</p>	<p>Remarks (R) Front Fender, Molding - Scratch - Minimal / (R) Mirror - Scratch - Minimal / (R) Front Door, Molding - Scratch - Minimal / (R) Step, In-panel, Side Spoiler - Scratch - Minimal / (R) Rear Door, Molding - Scratch - Small / (R) Rear Fender, Molding - Scratch - Minimal / Rear Bumper, Lamps, Panels - Scratch - Small / Trunk Hood, Rear Gate - Scratch - Minimal / (L) Rear Fender, Molding - Scratch & Dent - Minimal / Roof - Dent - Small / (L) Step, In-panel, Side Spoiler - Scratch - Minimal / (L) Rear Door, Molding - Scratch & Dent - Minimal / (L) Mirror - Scratch - Minimal / (L) Front Door, Molding - Dent - Minimal / (L) Front Door, Molding - Repair mark - Yes / (L) Front Fender, Molding - Repair mark - Yes / (L) Front Fender, Molding - Scratch - Minimal / Front Bumper, Grille, Lamps - Scratch - Medium / Bonnet, Headlight - Scratch & Dent - Minimal</p>
