## General Information

<b>Make</b>	Toyota	<b>Model</b>	Wigo
<b>YOM</b>	2024	<b>Odo Meter Reading</b>	35,352
<b>Registration No.</b>	NIQ8417	<b>Chassis No.</b>	MHKAA1BC8PJ008372
<b>CC</b>	1.0	<b>Transmission</b>	CVT
<b>Fuel Type</b>	Gas	<b>Type of Body</b>	Hatchback
<b>Colour</b>	Yellow

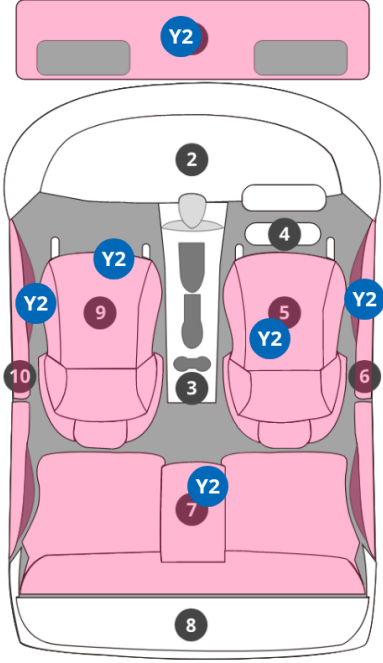
<p><b>a</b> : Cut, Fray <b>d</b> : Loose, Deformed <b>k</b> : Animal Hair <b>s</b> : Smell <b>t</b> : Cigarette Burns <b>x</b> : Defective <b>y</b> : Stain</p>

<p><b>A</b> : Scratch <b>AU</b> : Scratch &amp; Dent <b>B</b> : Modified <b>C</b> : Corrosion <b>G</b> : Stone chip <b>P</b> : Faded <b>S</b> : Rust <b>SC</b> : Rust &amp; Corrosion <b>U</b> : Dent <b>X</b> : Defective <b>Y</b> : Crack, Gap</p>
<p><b>Remarks</b> (L) Front Seat - Grime - Small / (R) Front Seat - Grime - Small / Rear Seat - Grime - Small / (L) Front Trim - Grime - Small / (R) Front Trim - Grime - Small / Ceiling - Grime - Small</p>	<p><b>Remarks</b> (R) Front Fender - Repair Traces - Yes / (L) Front Fender - Repair Traces - Yes / (L) Front Fender, Molding - Repair mark - Yes / (L) Front Fender, Molding - Scratch &amp; Dent - Small / (L) Front Door, Molding - Scratch &amp; Dent - Small / (L) Rear Door, Molding - Scratch &amp; Dent - Small / Roof - Scratch &amp; Dent - Small / (L) Rear Fender, Molding - Scratch &amp; Dent - Small / (L) Step, In-panel, Side Spoiler - Scratch &amp; Dent - Medium / Trunk Hood, Rear Gate - Scratch &amp; Dent - Small / Rear Bumper, Lamps, Panels - Scratch &amp; Dent - Medium / (R) Rear Fender, Molding - Scratch &amp; Dent - Small / (R) Rear Door, Molding - Scratch &amp; Dent - Medium / (R) Step, In-panel, Side Spoiler - Scratch &amp; Dent - Small / (R) Front Door, Molding - Scratch &amp; Dent - Small / (R) Front Fender, Molding - Scratch &amp; Dent - Small / Bonnet, Headlight - Scratch &amp; Dent - Small / Front Bumper, Grille, Lamps - Crack, Gap - Large</p>
