General Information

Make	Toyota	Model	Innova
YOM	2020	Odo Meter Reading	151,481
Registration No.	DBA7041	Chassis No.	PA2JA8EMXL008074
CC	2.8	Transmission	A/T
Fuel Type	Diesel	Type of Body	SUV
Colour	Red Mica Metallic

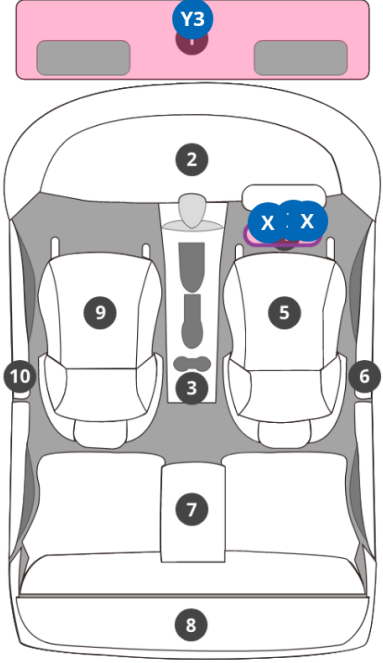
Interior Evaluation : B	Exterior Evaluation : E

<p>a : Cut, Fray d : Loose, Deformed k : Animal Hair s : Smell t : Cigarette Burns x : Defective y : Stain</p>

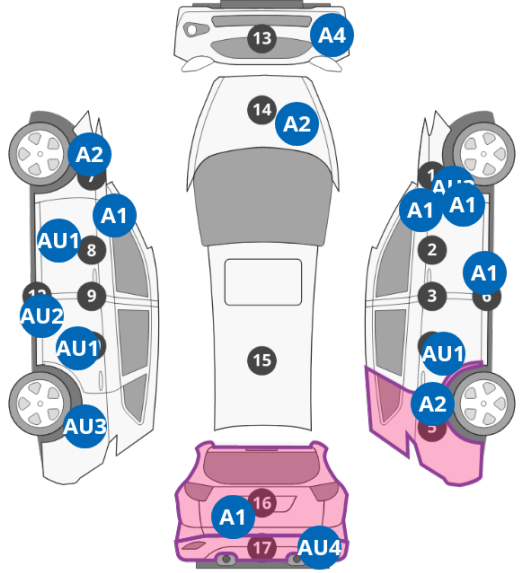
<p>A : Scratch AU : Scratch & Dent B : Modified C : Corrosion G : Stone chip P : Faded S : Rust SC : Rust & Corrosion U : Dent X : Defective Y : Crack, Gap</p>
Remarks (R) Front Floor Mat - Missing - Yes / (L) Front Floor Mat - Missing - Yes / Mat Other - Missing - Yes / Ceiling - Grime - Medium	Remarks (R) Rear Door - Repair Traces - Yes / (R) Front Fender, Molding - Scratch & Dent - Medium / (R) Mirror - Scratch, Peeled - Minimal / (R) Front Door, Molding - Scratch - Minimal / (R) Rear Fender, Molding - Repair mark - Yes / (R) Rear Fender, Molding - Scratch - Small / Rear Bumper, Lamps, Panels - Repair mark - Difference in Color / Rear Bumper, Lamps, Panels - Scratch & Dent - Large / (R) Step, In-panel, Side Spoiler - Scratch - Minimal / (R) Rear Door, Molding - Scratch & Dent - Minimal / Trunk Hood, Rear Gate - Repair mark - Yes / Trunk Hood, Rear Gate - Scratch - Minimal / (L) Rear Fender, Molding - Scratch & Dent - Medium / (L) Rear Door, Molding - Scratch & Dent - Minimal / (L) Front Door, Molding - Scratch & Dent - Minimal / (L) Mirror - Scratch, Peeled - Minimal / (L) Step, In-panel, Side Spoiler - Scratch & Dent - Small / (L) Front Fender, Molding - Scratch - Small / Front Bumper, Grille, Lamps - Scratch - Large / Bonnet, Headlight - Scratch - Small
