General Information

Make	Toyota	Model	Corolla Altis
YOM	2016	Odo Meter Reading	68,064
Registration No.	NDT5958	Chassis No.	MR053REH104545795
CC	1.6	Transmission	A/T
Fuel Type	Gas	Type of Body	Sedan
Colour	Black

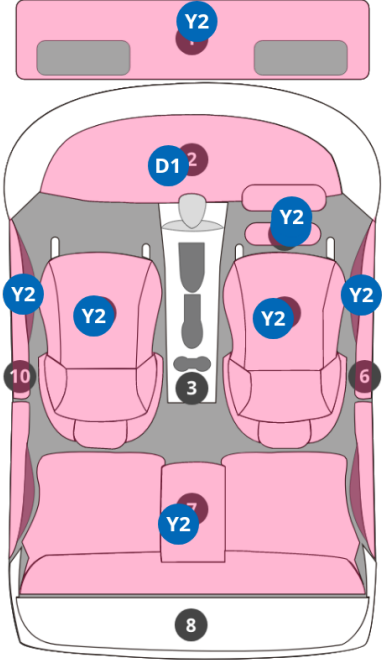
Interior Evaluation : B	Exterior Evaluation : E

<p>a : Cut, Fray d : Loose, Deformed k : Animal Hair s : Smell t : Cigarette Burns x : Defective y : Stain</p>

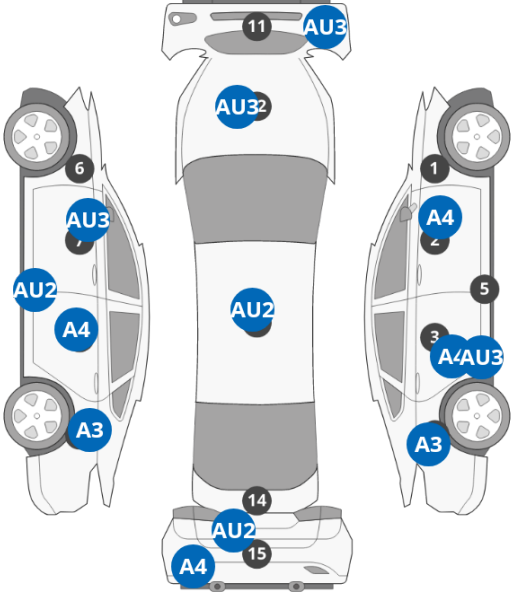
<p>A : Scratch AU : Scratch & Dent B : Modified C : Corrosion G : Stone chip P : Faded S : Rust SC : Rust & Corrosion U : Dent X : Defective Y : Crack, Gap</p>
<p>Remarks (L) Front Trim - Grime - Small / (R) Front Trim - Grime - Small / (L) Front Seat - Grime - Small / (R) Front Seat - Grime - Small / Rear Seat - Grime - Small / Ceiling - Grime - Small / Dashboard - Worked - Minimal / (R) Front Floor Mat - Grime - Small / (L) Front Floor Mat - Grime - Small</p>	<p>Remarks (R) Front Fender - Repair Traces - Yes / (L) Front Fender - Repair Traces - Yes / (L) Rear Fender - Repair Traces - Yes / (L) Front Door, Molding - Scratch & Dent - Medium / (L) Rear Door, Molding - Scratch - Large / (L) Rear Fender, Molding - Scratch - Medium / Rear Bumper, Lamps, Panels - Scratch - Large / Trunk Hood, Rear Gate - Scratch & Dent - Small / (R) Rear Fender, Molding - Scratch - Medium / Roof - Scratch & Dent - Small / (R) Rear Door, Molding - Scratch - Large / (R) Front Door, Molding - Scratch - Large / (R) Step, In-panel, Side Spoiler - Scratch & Dent - Medium / (L) Step, In-panel, Side Spoiler - Scratch & Dent - Small / Bonnet, Headlight - Scratch & Dent - Medium / Front Bumper, Grille, Lamps - Scratch & Dent - Medium</p>
