General Information

Make	Subaru	Model	WRX
YOM	2015	Odo Meter Reading	81,936
Registration No.	ARA1936	Chassis No.	JF1VAGL85FG004601
CC	2.0	Transmission	CVT
Fuel Type	Gas	Type of Body	Sedan
Colour	Blue

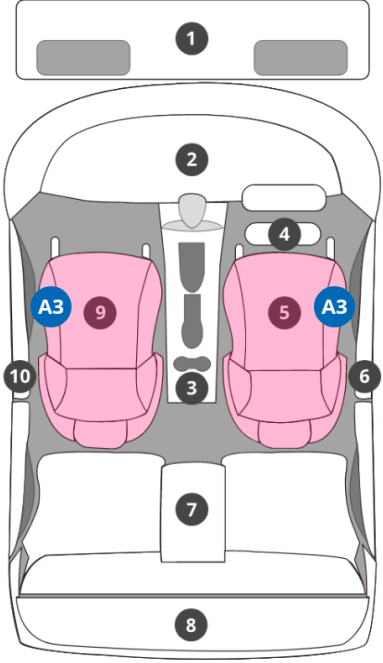
Interior Evaluation : B	Exterior Evaluation : D

<p>a : Cut, Fray d : Loose, Deformed k : Animal Hair s : Smell t : Cigarette Burns x : Defective y : Stain</p>

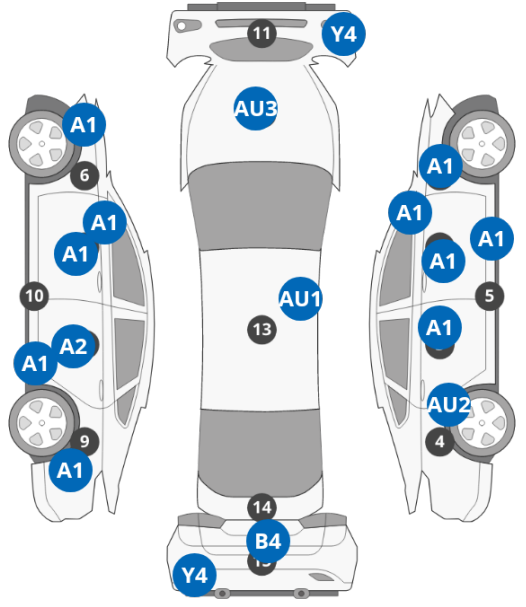
<p>A : Scratch AU : Scratch & Dent B : Modified C : Corrosion G : Stone chip P : Faded S : Rust SC : Rust & Corrosion U : Dent X : Defective Y : Crack, Gap</p>
<p>Remarks (L) Front Seat - Cut, Crack - Medium / (R) Front Seat - Cut, Crack - Medium</p>	<p>Remarks Bonnet - Repair Traces - Yes / (R) Front Fender, Molding - Scratch - Minimal / (R) Mirror - Scratch - Minimal / (R) Front Door, Molding - Scratch - Minimal / (R) Step, In-panel, Side Spoiler - Scratch - Minimal / (R) Rear Door, Molding - Scratch - Minimal / Roof - Scratch & Dent - Minimal / (R) Rear Fender, Molding - Scratch & Dent - Small / Rear Bumper, Lamps, Panels - Crack, Gap - Large / Trunk Hood, Rear Gate - Modified - Large / (L) Rear Fender, Molding - Scratch - Minimal / (L) Rear Door, Molding - Scratch - Small / (L) Step, In-panel, Side Spoiler - Scratch - Minimal / (L) Front Door, Molding - Scratch - Minimal / (L) Mirror - Scratch - Minimal / Bonnet, Headlight - Scratch & Dent - Medium / Front Bumper, Grille, Lamps - Crack, Gap - Large / (L) Front Fender, Molding - Scratch - Minimal</p>
