General Information

Make	Toyota	Model	Vios
YOM	2025	Odo Meter Reading	6,775
Registration No.	GBJ8152	Chassis No.	PA1B18F37S4286712
CC	1.3	Transmission	M/T
Fuel Type	Gas	Type of Body	Sedan
Colour	Silver

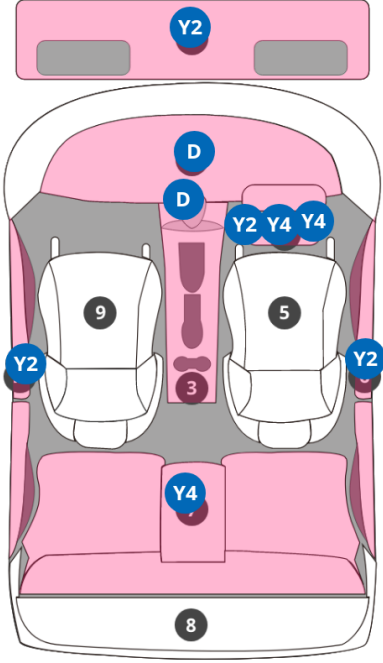
Interior Evaluation : C	Exterior Evaluation : E

<p>a : Cut, Fray d : Loose, Deformed k : Animal Hair s : Smell t : Cigarette Burns x : Defective y : Stain</p>

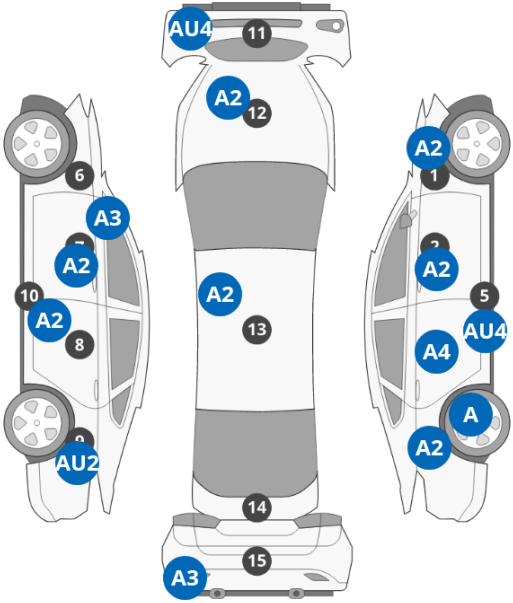
<p>A : Scratch AU : Scratch & Dent B : Modified C : Corrosion G : Stone chip P : Faded S : Rust SC : Rust & Corrosion U : Dent X : Defective Y : Crack, Gap</p>
<p>Remarks (L) Front Trim - Grime - Small / (L) Front Floor Mat - Grime - Small / Dashboard - Traces of Adhesive Tape - Yes / Ceiling - Grime - Small / Mat Other - Grime - Large / Rear Seat - Grime - Large / (R) Front Trim - Grime - Small / (R) Front Floor Mat - Grime - Large / Console, Switches, Vents - Traces of Adhesive Tape - Yes</p>	<p>Remarks (L) Front Door - Repair Traces - Yes / (L) Mirror - Scratch - Medium / (L) Front Door, Molding - Scratch - Small / (L) Rear Door, Molding - Scratch - Small / (L) Rear Fender, Molding - Scratch & Dent - Small / (R) Rear Door, Molding - Scratch - Large / Rear Bumper, Lamps, Panels - Scratch - Medium / (R) Rear Fender, Molding - Scratch - Small / (R) Front Door, Molding - Scratch - Small / (R) Step, In-panel, Side Spoiler - Scratch & Dent - Large / (R) Front Fender, Molding - Scratch - Small / Front Bumper, Grille, Lamps - Scratch & Dent - Large / Bonnet, Headlight - Scratch - Small / Roof - Scratch - Small / (R) Rear Tyre - Crack, Cut - Yes</p>

<p>Inspector Notes</p>
<p>Punctured rear right tire. Unusual sound at the exhaust area. Fog light cover issue and Foglight loose. Door lock switch not working. Gap at front bumper, front left door and rear bumper. Scratches at headlight and taillight. Adhesive mark at left side mirror. With warranty booklet, spare tire and jack. Without tools. Incomplete seat cover. 2 keys. With LTO plate.</p>
