## General Information

| Make | Toyota | Model | Vios |
| YOM | 2019 | Odo Meter Reading | 65,140 |
| Registration No. | NFT5919 | Chassis No. | PA1B13F31K4095063 |

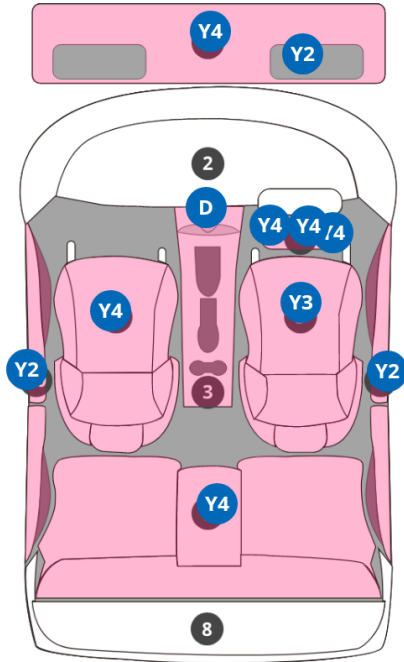
| Interior Evaluation : <b>E</b> | Exterior Evaluation : <b>E</b> |
| <p><b>Remarks</b></p> <p>(R) Front Trim - Grime - Small / (R) Front Floor Mat - Grime - Large / (R) Front Seat - Grime - Medium / Sunvisor, Sunglass Holder - Grime - Small / Ceiling - Grime - Large / Rear Seat - Grime - Large / Mat Other - Grime - Large / (L) Front Trim - Grime - Small / (L) Front Seat - Grime - Large / (L) Front Floor Mat - Grime - Large / Console, Switchs, Vents - Traces of Adhesive Tape - Yes</p> | <p><b>Remarks</b></p> <p>Trunk Hood, Rear Gate - Repair Traces - Yes / (R) Rear Door - Repair Traces - Yes / Bonnet, Headlight - Scratch - Large / Front Bumper, Grille, Lamps - Scratch &amp; Dent - Large / Front Bumper, Grille, Lamps - Modified - Medium / (L) Front Fender, Molding - Scratch &amp; Dent - Small / (L) Mirror - Scratch - Medium / (L) Front Door, Molding - Scratch - Medium / (L) Rear Door, Molding - Scratch - Large / (L) Rear Fender, Molding - Repair mark - Yes / (L) Rear Fender, Molding - Scratch &amp; Dent - Large / (L) Step, In-panel, Side Spoiler - Scratch &amp; Dent - Medium / Trunk Hood, Rear Gate - Scratch &amp; Dent - Minimal / Rear Bumper, Lamps, Panels - Repair mark - Yes / Rear Bumper, Lamps, Panels - Scratch &amp; Dent - Large / (R) Rear Fender, Molding - Scratch - Small / (R) Rear Door, Molding - Scratch &amp; Dent - Medium / (R) Step, In-panel, Side Spoiler - Scratch &amp; Dent - Small / (R) Mirror - Scratch - Small / (R) Front Door, Molding - Scratch - Small / (R) Front Fender, Molding - Repair mark - Yes / (R) Front Fender, Molding - Scratch - Small / Antennae - Stuck - Yes / Roof - Scratch &amp; Dent - Small</p> |

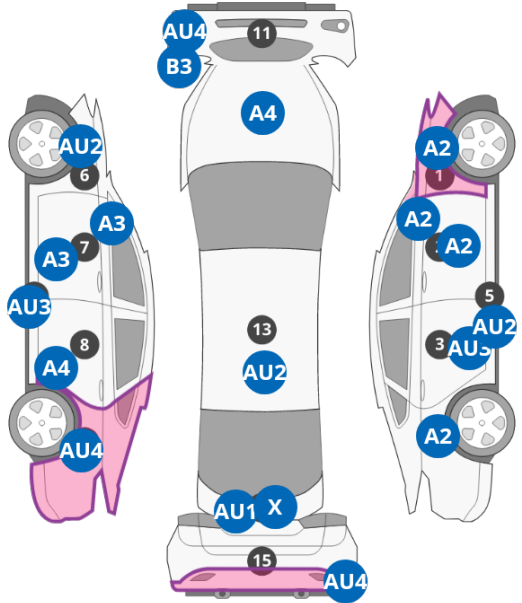
| Inspector Notes |
|---|
| <p>Possible flooding. Crack taillight. Scratches on headlight and taillight. Glove box loose. Trunk floor has a hole. Scratches at Antenna. Without warranty booklet, jack, tools and seat cover. With spare tire. 2 keys no remote. With LTO plate.</p> |
