## General Information

<b>Make</b>	Toyota	<b>Model</b>	Vios
<b>YOM</b>	2025	<b>Odo Meter Reading</b>	5,983
<b>Registration No.</b>	GBK4309	<b>Chassis No.</b>	PA1B18F38S4290736
<b>CC</b>	1.3	<b>Transmission</b>	CVT
<b>Fuel Type</b>	Gas	<b>Type of Body</b>	Sedan
<b>Colour</b>	Red Mica Metallic

## Body / Panel Condition

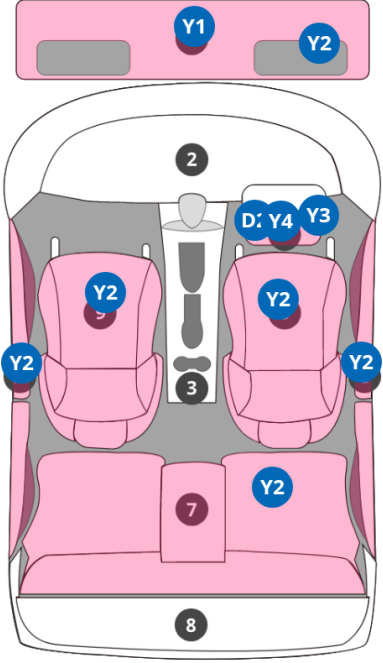
<b>Interior Evaluation :</b> <span style="color: red; font-weight: bold; font-size: 1.2em;">C</span>	<b>Exterior Evaluation :</b> <span style="color: red; font-weight: bold; font-size: 1.2em;">D</span>

<p><b>a</b> : Cut, Fray <b>d</b> : Loose, Deformed <b>k</b> : Animal Hair <b>s</b> : Smell <b>t</b> : Cigarette Burns <b>x</b> : Defective <b>y</b> : Stain</p>

<p><b>Inspector Notes</b></p>
<p>Rusted seat railings. Small Grime at Front right carpet. Scratches on headlight, taillight and front windshield. With warranty booklet, spare tire and jack. Incomplete tools. Without seat cover. 1 key. No LTO plate.</p>

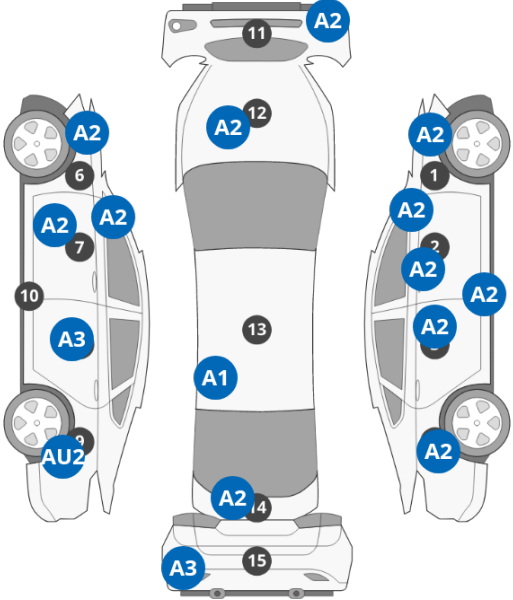
<p><b>A</b> : Scratch <b>AU</b> : Scratch &amp; Dent <b>B</b> : Modified <b>C</b> : Corrosion <b>G</b> : Stone chip <b>P</b> : Faded <b>S</b> : Rust <b>SC</b> : Rust &amp; Corrosion <b>U</b> : Dent <b>X</b> : Defective <b>Y</b> : Crack, Gap</p>
<p><b>Remarks</b> (L) Front Trim - Grime - Small / (L) Front Floor Mat - Worked - Small / (L) Front Seat - Grime - Small / Sunvisor, Sunglass Holder - Grime - Small / Mat Other - Grime - Large / Ceiling - Grime - Minimal / Rear Seat - Grime - Small / (R) Front Trim - Grime - Small / (R) Front Floor Mat - Grime - Medium / (R) Front Seat - Grime - Small</p>	<p><b>Remarks</b> (L) Front Fender, Molding - Scratch - Small / (L) Mirror - Scratch - Small / (L) Front Door, Molding - Scratch - Small / (L) Rear Door, Molding - Scratch - Medium / (L) Rear Fender, Molding - Scratch &amp; Dent - Small / Trunk Hood, Rear Gate - Scratch - Small / Rear Bumper, Lamps, Panels - Scratch - Medium / (R) Rear Fender, Molding - Scratch - Small / (R) Rear Door, Molding - Scratch - Small / (R) Front Door, Molding - Scratch - Small / (R) Mirror - Scratch - Small / (R) Step, In-panel, Side Spoiler - Scratch - Small / (R) Front Fender, Molding - Scratch - Small / Front Bumper, Grille, Lamps - Scratch - Small / Bonnet, Headlight - Scratch - Small / Roof - Scratch - Minimal</p>
