General Information

Make	Toyota	Model	Vios
YOM	2024	Odo Meter Reading	1
Registration No.	HAG8538	Chassis No.	PA1B18F35R4259549
CC	1.3	Transmission	CVT
Fuel Type	Gas	Type of Body	Sedan
Colour	Red

Body / Panel Condition

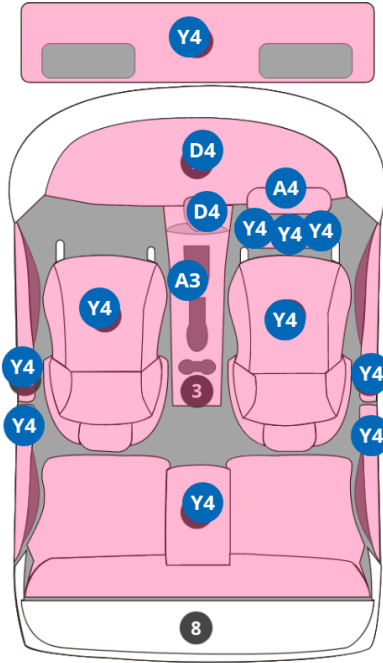
Interior Evaluation : E	Exterior Evaluation : N / A
<div style="text-align: center;">

</div> <p>a : Cut, Fray d : Loose, Deformed k : Animal Hair s : Smell t : Cigarette Burns x : Defective y : Stain</p>	
<p>Remarks (R) Front Trim - Grime - Large / (R) Rear Trim - Grime - Large / (R) Front Seat - Grime - Large / (R) Front Floor Mat - Grime - Large / (L) Front Floor Mat - Grime - Large / Mat Other - Grime - Large / (L) Front Seat - Grime - Large / Rear Seat - Grime - Large / Dashboard - Loose, Deformed - Large / Ceiling - Grime - Large / Steering Wheel - Worn, Peel, Crack - Large / Knobs - Worn, Peel, Crack - Medium / Console, Switches, Vents - Worked - Large / (L) Rear Trim - Grime - Large / (L) Front Trim - Grime - Large</p>	<p>Remarks Defects not found</p>
Frame Evaluation : N / A	Functional Evaluation : N / A
<p>Remarks Defects not found</p>	<p>Remarks Defects not found</p>
