General Information

Make	Toyota	Model	Vios
YOM	2023	Odo Meter Reading	98,902
Registration No.	DAS6794	Chassis No.	PA1B18F32N4194134
CC	1.3	Transmission	CVT
Fuel Type	Gas	Type of Body	Sedan
Colour	Blue

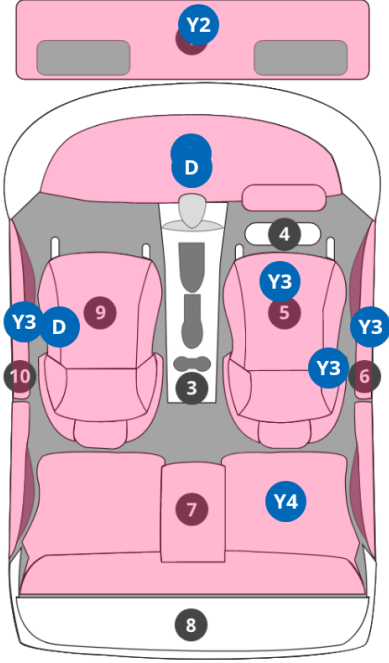
Interior Evaluation : C	Exterior Evaluation : D

<p>a : Cut, Fray d : Loose, Deformed k : Animal Hair s : Smell t : Cigarette Burns x : Defective y : Stain</p>

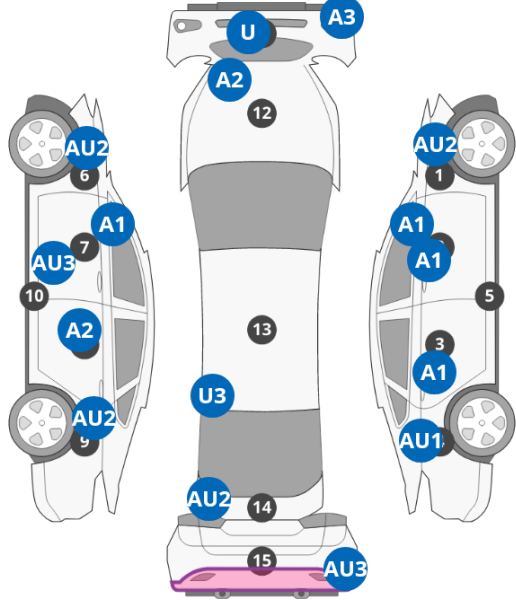
<p>A : Scratch AU : Scratch & Dent B : Modified C : Corrosion G : Stone chip P : Faded S : Rust SC : Rust & Corrosion U : Dent X : Defective Y : Crack, Gap</p>
<p>Remarks (R) Front Seat - Grime - Medium / (R) Front Seat belt - Grime - Medium / Rear Seat - Grime - Large / (L) Front Seat - Worn - Yes / Overall Interior - Worn as per age - Yes / Overall Interior - Smell - Yes / (R) Front Trim - Grime - Medium / (L) Front Trim - Grime - Medium / Ceiling - Grime - Small / Dashboard - Traces of Adhesive Tape - Yes</p>	<p>Remarks (L) Rear Fender - Repair Traces - Yes / Member (Bolted) - Dent - Yes / (R) Front Fender, Molding - Scratch & Dent - Small / (R) Mirror - Scratch - Minimal / (R) Front Door, Molding - Scratch - Minimal / (R) Rear Door, Molding - Scratch - Minimal / (R) Rear Fender, Molding - Scratch & Dent - Minimal / Rear Bumper, Lamps, Panels - Repair mark - Yes / Rear Bumper, Lamps, Panels - Scratch & Dent - Medium / Trunk Hood, Rear Gate - Scratch & Dent - Small / (L) Rear Fender, Molding - Scratch & Dent - Small / Roof - Dent - Medium / (L) Front Door, Molding - Scratch & Dent - Medium / (L) Rear Door, Molding - Scratch - Small / (L) Mirror - Scratch - Minimal / (L) Front Fender, Molding - Scratch & Dent - Small / Front Bumper, Grille, Lamps - Scratch - Medium / Bonnet, Headlight - Scratch - Small</p>
