General Information

Make	Toyota	Model	Vios
YOM	2023	Odo Meter Reading	128,563
Registration No.	DBG7560	Chassis No.	PA1B18F32P4202657
CC	1.3	Transmission	CVT
Fuel Type	Gas	Type of Body	Sedan
Colour	Red

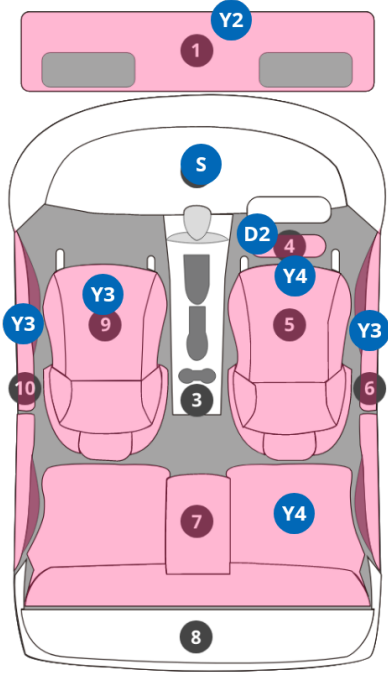
Interior Evaluation : C	Exterior Evaluation : E

<p>a : Cut, Fray d : Loose, Deformed k : Animal Hair s : Smell t : Cigarette Burns x : Defective y : Stain</p>

<p>A : Scratch AU : Scratch & Dent B : Modified C : Corrosion G : Stone chip P : Faded S : Rust SC : Rust & Corrosion U : Dent X : Defective Y : Crack, Gap</p>
<p>Remarks (R) Front Seat - Grime - Large / Rear Seat - Grime - Large / (L) Front Seat - Grime - Medium / (L) Front Floor Mat - Worked - Small / Ceiling - Grime - Small / (R) Front Trim - Grime - Medium / (L) Front Trim - Grime - Medium / Overall Interior - Worn as per age - Yes / Overall Interior - Smell - Yes</p>	<p>Remarks (R) Front Fender - Repair Traces - Yes / Bonnet - Repair Traces - Yes / (L) Rear Door - Repair Traces - Yes / (L) Rear Fender - Repair Traces - Yes / (R) Front Fender, Molding - Scratch & Dent - Small / Member (Bolted) - Dent - Yes / Front Bumper, Grille, Lamps - Repair mark - Yes / (R) Mirror - Scratch - Small / (R) Rear Door, Molding - Repair mark - Yes / (R) Front Door, Molding - Scratch - Small / (R) Rear Fender, Molding - Scratch & Dent - Medium / (R) Rear Door, Molding - Dent - Medium / Rear Bumper, Lamps, Panels - Repair mark - Yes / Overall Exterior - Worn as per age - Yes / Overall Exterior - Re-Paint Uneven - Yes / Rear Bumper, Lamps, Panels - Scratch - Medium / (L) Front Door, Molding - Repair mark - Yes / (L) Rear Door, Molding - Repair mark - Yes / (L) Rear Fender, Molding - Scratch & Dent - Large / (L) Rear Door, Molding - Scratch - Medium / (L) Front Door, Molding - Scratch - Small / (L) Mirror - Scratch - Small / (L) Front Fender, Molding - Scratch - Small / Bonnet, Headlight - Repair mark - Yes / Front Bumper, Grille, Lamps - Scratch - Medium / Bonnet, Headlight - Scratch - Small / Roof - Scratch & Dent - Small / Trunk Hood, Rear Gate - Crack, Gap - Medium</p>
